**Case Study 6**

**Big Bear Creek, Lycoming County,  
Pennsylvania**

# Big Bear Creek, Lycoming County, Pennsylvania

*By Dr. Larry K. Brannaka, U.S. Fish and Wildlife Service (USFWS); David B. Putnam, USFWS; William Worobec, Dunwoody-Big Bear Hunting and Fishing Club, Lycoming County, Pennsylvania; and Donald Stover. (All are members of the Keystone Stream Team.)*

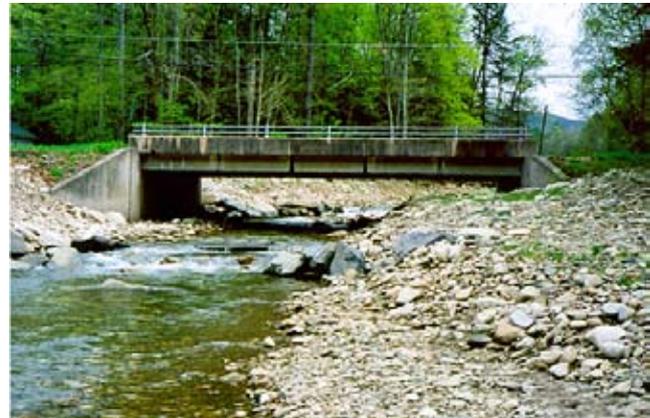
**Figure CS6-4** Most downstream PennDOT bridge on Big Bear Creek

lower two bridges were built by the Pennsylvania Department of Transportation (PennDOT). The farthest downstream bridge just above the confluence of Big Bear Creek with Loyalsock Creek (fig. CS6-4), frequently filled with sediment—mostly gravel, cobble, and boulders.

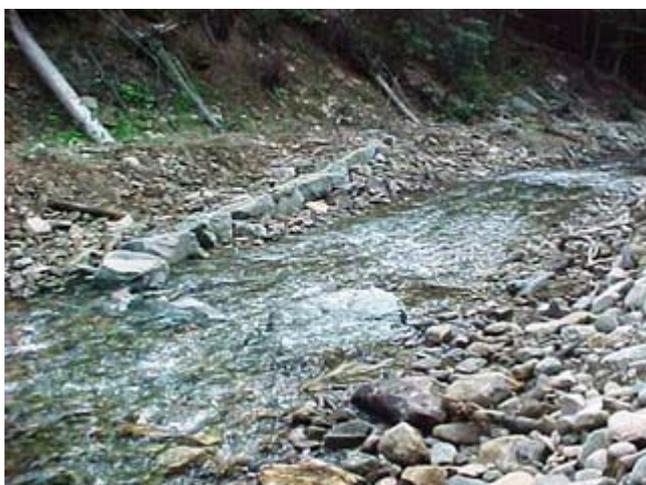
**Figure CS6-7** J-hook rock vane on Big Bear Creek

For the most part, the rock vanes performed well. However, problems were encountered with some of the vanes. Some of the vanes had to be tweaked, some needed to be rebuilt after being damaged by high flow, and some vanes were torn out and relocated to achieve the objective for each vane. Two construction crews worked in the phase II and phase III of the project. One crew had very good luck with their structures, but the other did not. Unfortunately, communication between crews was lacking, especially with regard to procedures, construction techniques, and expectations. Consequently, the good luck was not always shared. When the construction operator paid attention to detail and maintained the patience required in fitting the rocks securely together, the structures held up against bankfull events. Attention to detail in the construction resulted in a stable structure.

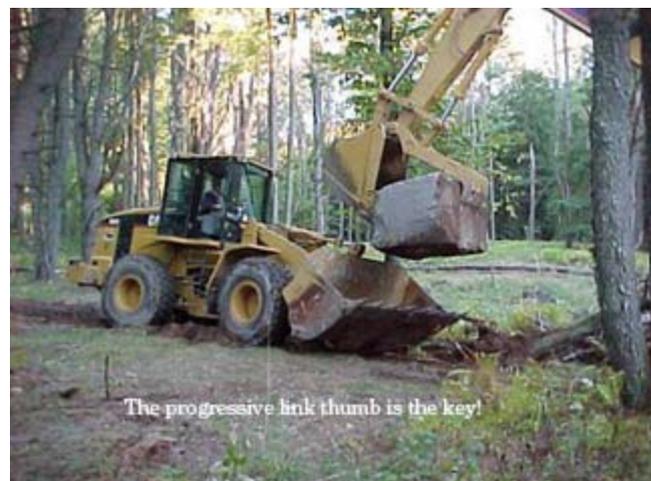
**Figure CS6–10** Loading a typical wall rock used for vane construction

**Rock**—Wall rock (fig. CS6–10) is preferred over smaller R5–R7 size rock. Vanes constructed of the smaller rock give the appearance of being simply piled, and it is much harder to plug the holes between the rocks. The wall rock is more massive and lends itself to placement with an excavator. The wall rock also provides good footer rocks. Size specifications for the wall rock for this project indicated rock dimensions should be between 3 and 6 feet, with no dimension less than 3 feet and no dimension greater than 6 feet. The rock was to be of hard sandstone with an alkaline pH, or limestone. One of the biggest challenges is transporting rock of this size. Large steel-bed dump trucks were used to deliver 8 to 10 rocks at a time. Depending on the truck tailgate configuration, it was sometimes necessary for the excavator to unload the rock from the truck. Typically the rock was stored at a staging area near the construction site and delivered

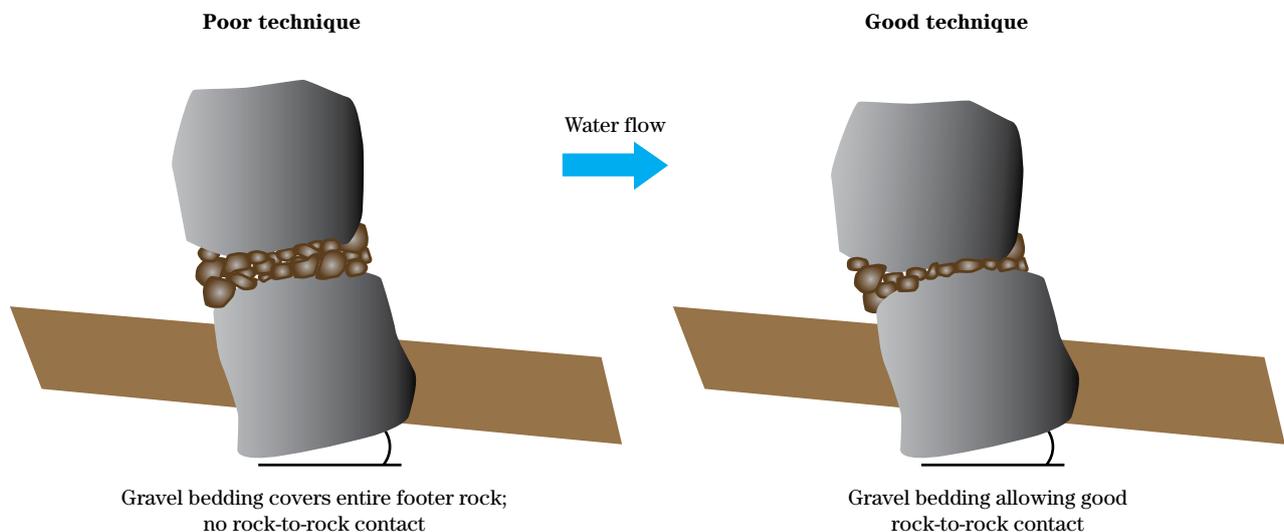
**Figure CS6–11** Schematic of vane rock installation

resulted in less excavation into the stream subbase to set the throat rocks at or near the streambed level. Over the long term, it was found that these structures were much more susceptible to washouts and displacement of the throat rocks than those where all the vane rocks were carefully placed on footer rocks of comparable size. High velocity flows moving over the vanes scoured out the downstream pavement and subbase of the streambed, tipping or causing settling of the footer rock, which in turn caused the vane rock to fall into the scour hole. The process repeated itself, eroding a scour hole downstream of the tipped rock until it rolled into the hole, thereby moving the rock downstream. An example of this is shown in figure CS6-12.

erly installed footer rock is tilted slightly upstream. For the vane rock to move downstream, it must also move uphill (fig. CS6-11).

Once the footer rock is set, leaning slightly upstream, gravel bedding may be dribbled on top of the footer rock. The vane rock is then placed on top and scrunched back and forth until there is direct contact between the vane and footer rock at least at one point (fig. CS6-11). For a time, one construction crew ignored this tenet and just placed vane rocks on top of bedding gravel. Without the rock-to-rock contact, it is relatively easy to displace the vane rock and roll it off of the footer rock. Some of the vane rocks observed had most of the gravel bedding scoured out from beneath the vane rock. Patience and persistence are required. If the vane rock is not set at the proper elevation, the footer rock must be raised and some streambed material moved underneath to support it. If the vane rock must be lowered, a deeper hole should be dug before replacing the footer rock.

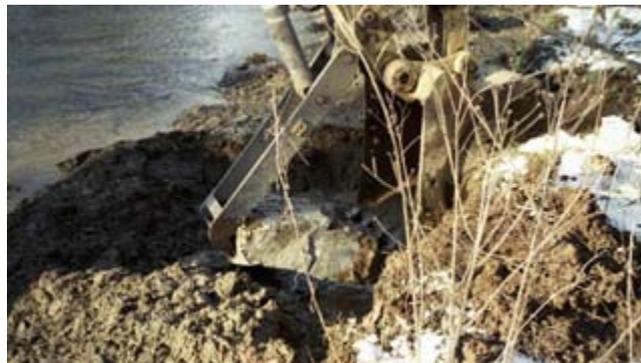
**Figure CS6-13** Setting a footer rock (upstream direction is to the right)

Footer rocks of the proper size are typically embedded into the streambed to a depth greater than the scour depth and, thus, resist washout. Figure CS6-13 shows a footer rock being set. Two other features of a properly footed vane rock also help to resist tip-outs of the vane rock. First, the vane rock is typically offset to the upstream side of the footer rock (fig. CS6-11) leaving a small sill at the base of the vane rock. This sill sometimes acts as an energy dissipater for water pouring over the vane rock. The second feature is that a prop-

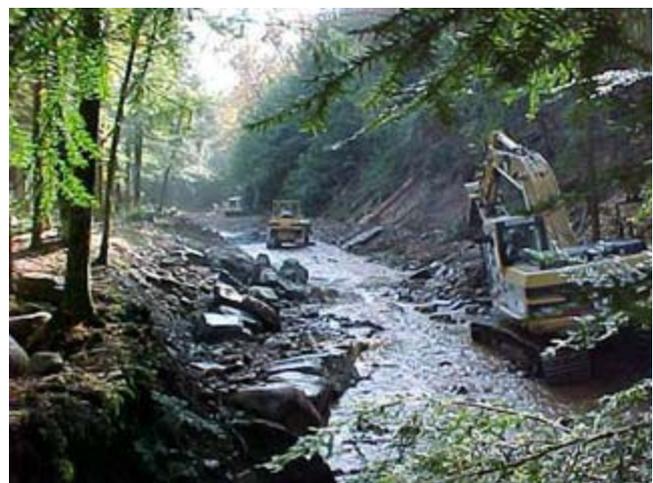
**Figure CS6–19** The open heart surgery approach, working with heavy equipment in the channel of Big Bear Creek

Perhaps one of the most potentially controversial issues in the construction of the restoration project was working in the stream channel, in the wet, with heavy construction equipment (fig. CS6–19). The USFWS personnel practiced a no tolerance policy regarding equipment malfunction and leaking fluids. If equipment leaked or dripped any nonaqueous fluid, it was immediately removed from the channel area and repaired.
