Case Study 6

**Big Bear Creek, Lycoming County,
Pennsylvania**

Big Bear Creek, Lycoming County, Pennsylvania

By Dr. Larry K. Brannaka, U.S. Fish and Wildlife Service (USFWS); David B. Putnam, USFWS; William Worobec, Dunwoody-Big Bear Hunting and Fishing Club, Lycoming County, Pennsylvania; and Donald Stover. (All are members of the Keystone Stream Team.)

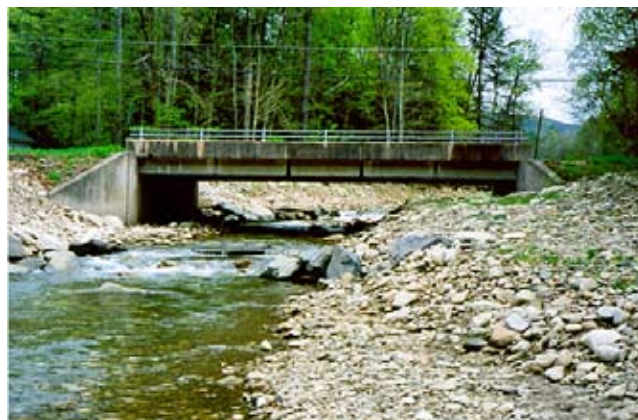
Figure CS6-4 Most downstream PennDOT bridge on Big Bear Creek

lower two bridges were built by the Pennsylvania Department of Transportation (PennDOT). The farthest downstream bridge just above the confluence of Big Bear Creek with Loyalsock Creek (fig. CS6-4), frequently filled with sediment—mostly gravel, cobble, and boulders.

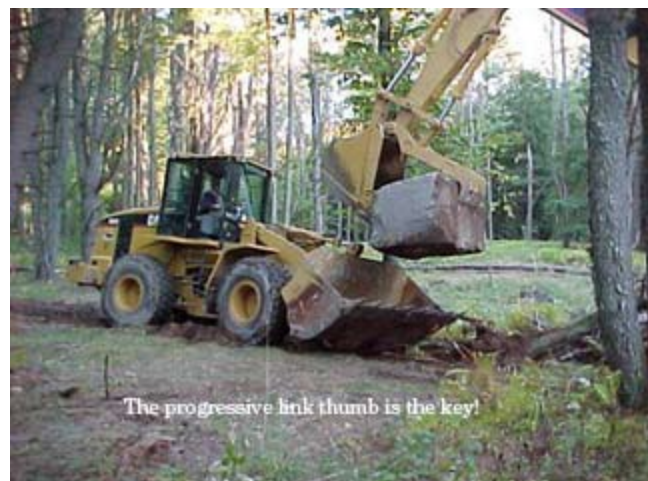
Figure CS6–10 Loading a typical wall rock used for vane construction

Rock—Wall rock (fig. CS6–10) is preferred over smaller R5–R7 size rock. Vanes constructed of the smaller rock give the appearance of being simply piled, and it is much harder to plug the holes between the rocks. The wall rock is more massive and lends itself to placement with an excavator. The wall rock also provides good footer rocks. Size specifications for the wall rock for this project indicated rock dimensions should be between 3 and 6 feet, with no dimension less than 3 feet and no dimension greater than 6 feet. The rock was to be of hard sandstone with an alkaline pH, or limestone. One of the biggest challenges is transporting rock of this size. Large steel-bed dump trucks were used to deliver 8 to 10 rocks at a time. Depending on the truck tailgate configuration, it was sometimes necessary for the excavator to unload the rock from the truck. Typically the rock was stored at a staging area near the construction site and delivered

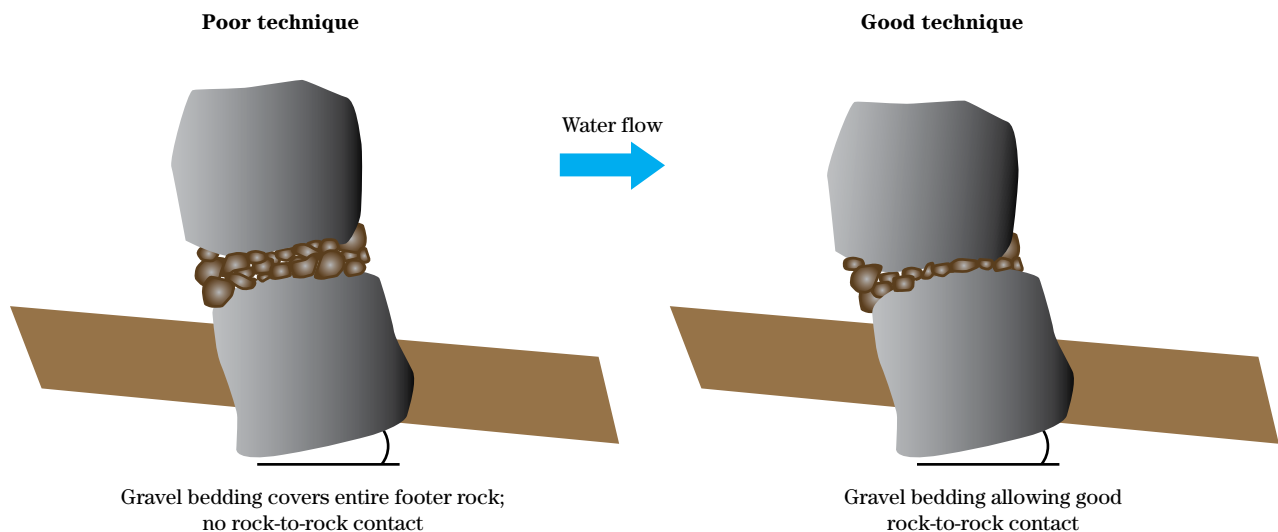
Figure CS6–11 Schematic of vane rock installation

resulted in less excavation into the stream subbase to set the throat rocks at or near the streambed level. Over the long term, it was found that these structures were much more susceptible to washouts and displacement of the throat rocks than those where all the vane rocks were carefully placed on footer rocks of comparable size. High velocity flows moving over the vanes scoured out the downstream pavement and subbase of the streambed, tipping or causing settling of the footer rock, which in turn caused the vane rock to fall into the scour hole. The process repeated itself, eroding a scour hole downstream of the tipped rock until it rolled into the hole, thereby moving the rock downstream. An example of this is shown in figure CS6-12.

Footer rocks of the proper size are typically embedded into the streambed to a depth greater than the scour depth and, thus, resist washout. Figure CS6-13 shows a footer rock being set. Two other features of a properly footed vane rock also help to resist tip-outs of the vane rock. First, the vane rock is typically offset to the upstream side of the footer rock (fig. CS6-11) leaving a small sill at the base of the vane rock. This sill sometimes acts as an energy dissipater for water pouring over the vane rock. The second feature is that a prop-

erly installed footer rock is tilted slightly upstream. For the vane rock to move downstream, it must also move uphill (fig. CS6-11).

Once the footer rock is set, leaning slightly upstream, gravel bedding may be dribbled on top of the footer rock. The vane rock is then placed on top and scrunched back and forth until there is direct contact between the vane and footer rock at least at one point (fig. CS6-11). For a time, one construction crew ignored this tenet and just placed vane rocks on top of bedding gravel. Without the rock-to-rock contact, it is relatively easy to displace the vane rock and roll it off of the footer rock. Some of the vane rocks observed had most of the gravel bedding scoured out from beneath the vane rock. Patience and persistence are required. If the vane rock is not set at the proper elevation, the footer rock must be raised and some streambed material moved underneath to support it. If the vane rock must be lowered, a deeper hole should be dug before replacing the footer rock.

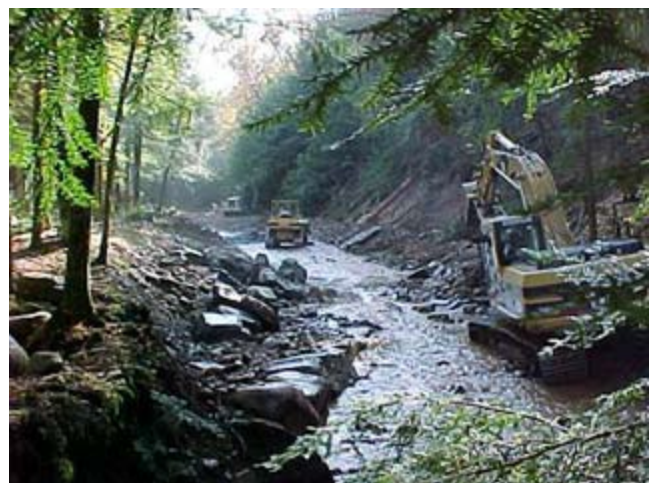
Figure CS6–19 The open heart surgery approach, working with heavy equipment in the channel of Big Bear Creek

Perhaps one of the most potentially controversial issues in the construction of the restoration project was working in the stream channel, in the wet, with heavy construction equipment (fig. CS6–19). The USFWS personnel practiced a no tolerance policy regarding equipment malfunction and leaking fluids. If equipment leaked or dripped any nonaqueous fluid, it was immediately removed from the channel area and repaired.
