Issued August 2007

# Technical Supplement 14A

# Soil Properties and Special Geotechnical Problems Related to Stream Stabilization Projects

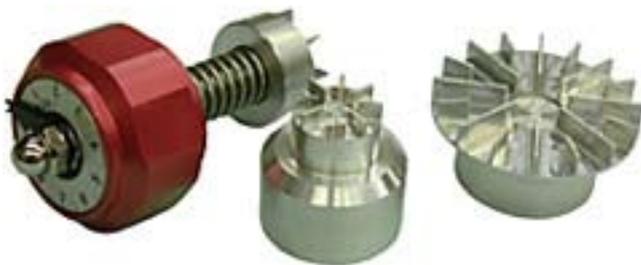
**Figure TS14A-1** Hand held torvane device (Photo courtesy Geotest Instruments, Inc.)

The saturated consistency of fine-grained soils with significant plasticity (plasticity index greater than about 7) correlates well with the soils' undrained shear strength. Saturated undrained strength of plastic fine-grained soils may be estimated with a field torvane device such as the one shown in figure TS14A-1 or from the descriptions provided in table TS14A-2.

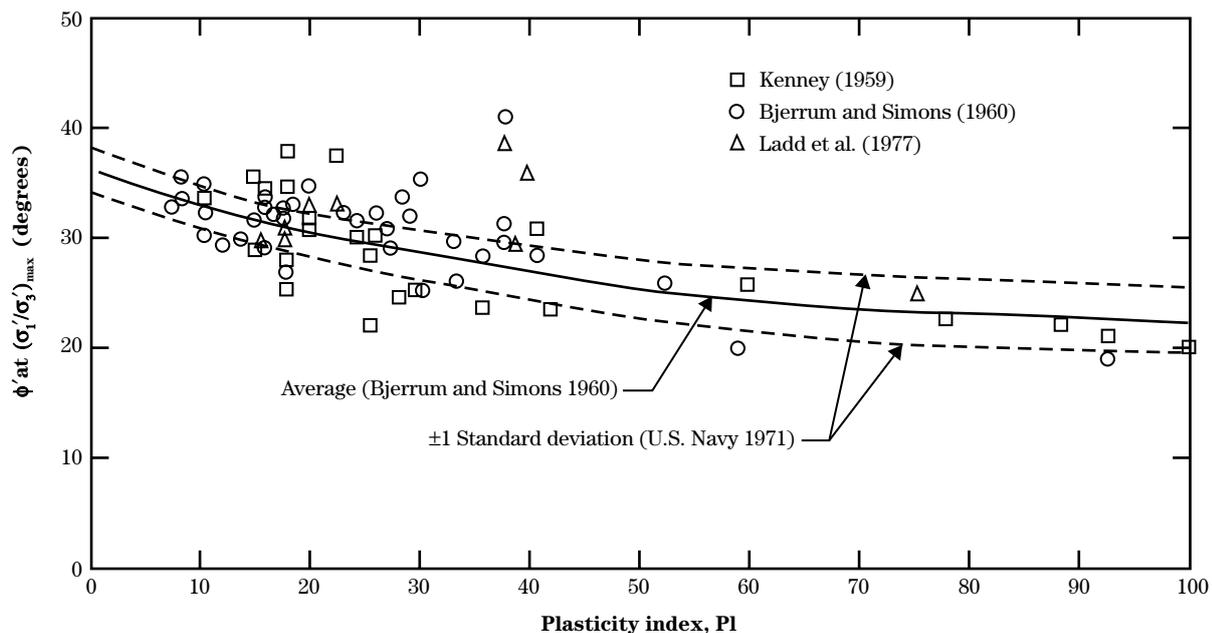
**Figure TS14A-2** Empirical correlation between effective phi angle ( $\phi$ ) and plasticity index (PI) from triaxial tests on normally consolidated clays

Analyses of fine-grain soils should consider both undrained and drained conditions, with the most critical condition governing the design. Typical soil properties for fine-grain materials are shown in table TS14A-3 (U.S. Army Corps of Engineers (USACE) 1994c, EM 1110-2-2504, Design of Sheet Pile Walls; Pile Buck Steel Sheet Piling Design Manual; and U.S. Navy, Naval Facilities Engineering Command (NAVFAC) DM-7.2, Foundations and Earth Structures). Peak effective  $\phi$  ( $\phi$ ) angles for slowly permeable soils may be estimated with empirical charts such as shown in figure TS14A-2 (Hopkins, Allen, and Dean 1974; Kenny 1959; Bjerrum and Simons 1960).

- 1/ See tables TS14A-1 and TS14A-2 for qualitative descriptions of soil types.
- 2/ See figure TS14A-2.
- 3/ Wall/soil adhesion is typically 0 for drained (long-term) conditions.

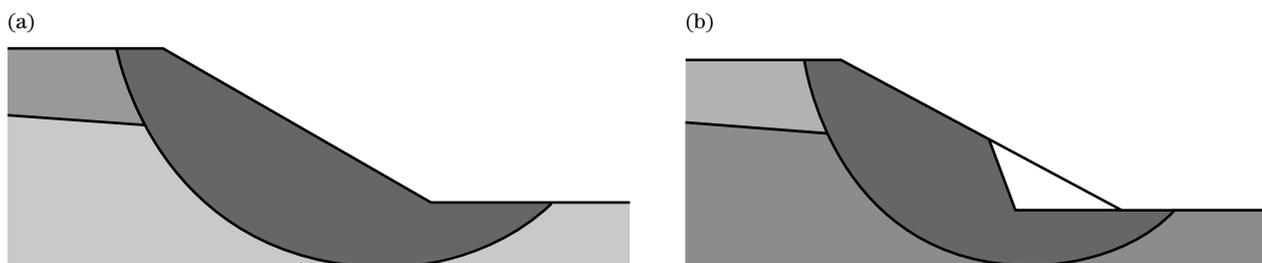
**Figure TS14A-3** Factor of safety computed before and after erosion of toe of slope: (a) before, FS=1.107; (b) after, FS=0.99

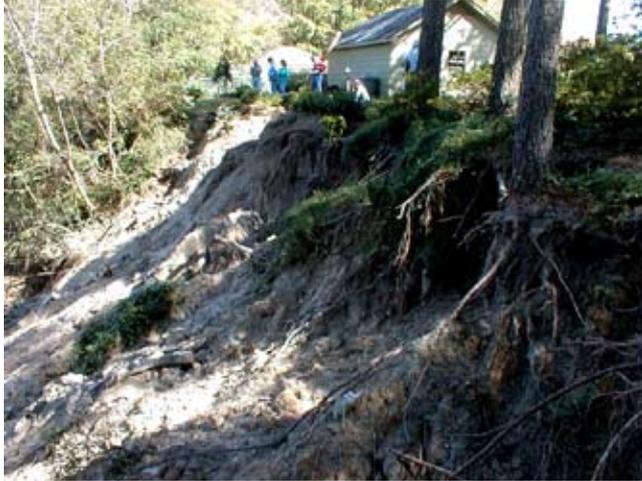
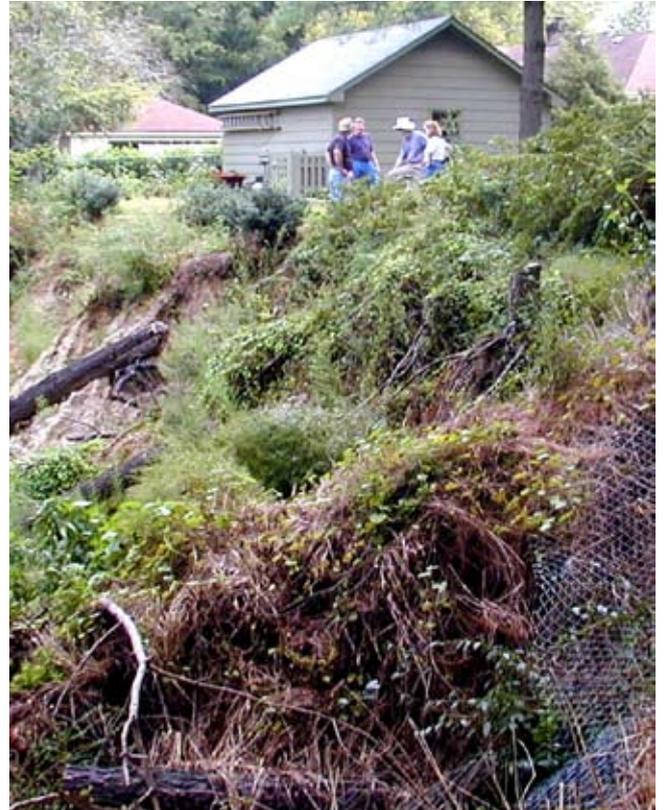
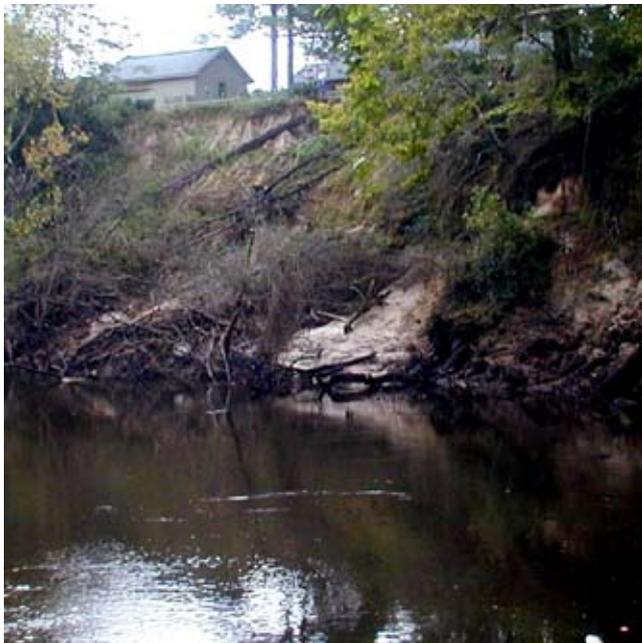
**Figure TS14A-4** Failed streambank in Tarboro, NC, following high channel flows following Hurricane Floyd. Erosion of the toe caused bank instability in the slope. Measures to protect the toe of the slope are essential, in addition to assuring stability of the system.

Figure TS14A-4 shows a slope where erosion of the toe has caused slope instability. In figure TS14A-4(a), the overall slope is seen with erosion that occurred at the toe of the slope following a large runoff event. Figure TS14A-4(b) shows the effect of the slope failure at the top of the slope, and figure TS14A-4(c) shows the middle of the failed slope area. Other ways that slope geometry or conditions may change, resulting in instability, include:

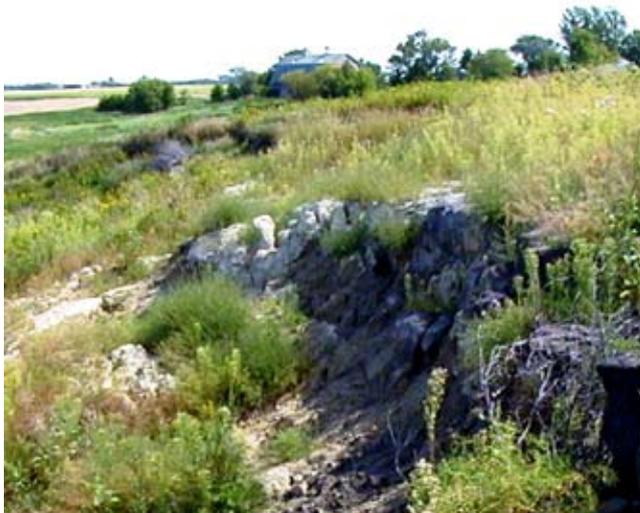
**Figure TS14A-5** Shallow sloughing failure in zone of saturated sand

Figure TS14A-5 shows a shallow slide occurring from a zone of saturated sand sloughing from seepage forces. Figure TS14A-6 shows the results of a deep-seated rotational failure in clayey soils. A later section in the document describes this type of failure in detail.

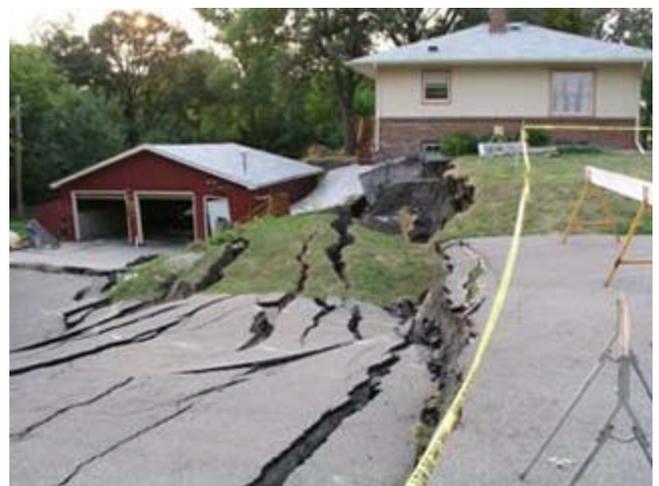
**Figure TS14A-6** Typical slope stability failure in clay soil type. Failure is a low-radius, deep rotational failure. (Photo credit City of Fargo, ND)

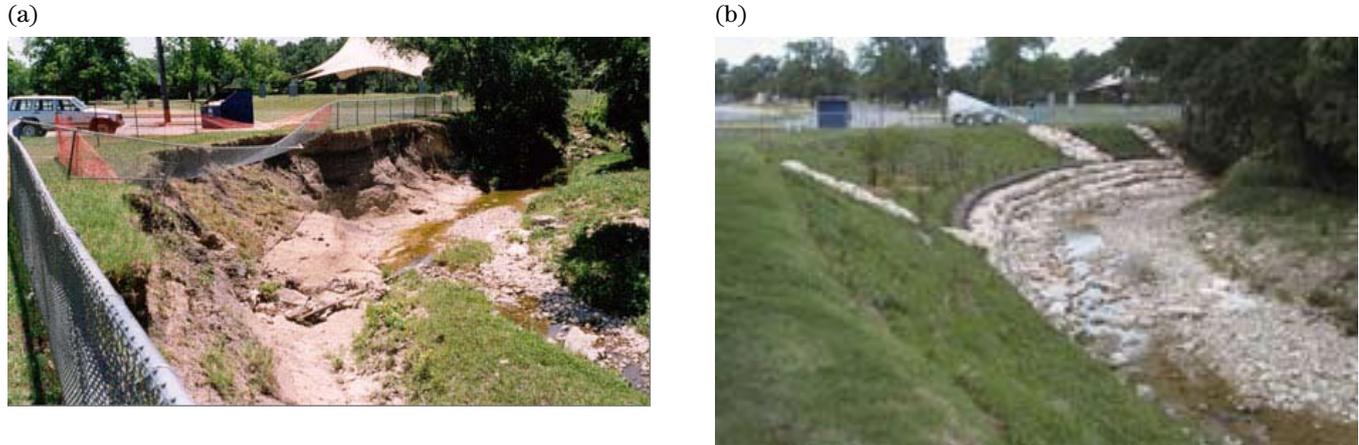
**Figure TS14A-7** Before and after pictures of project, Tannehill Branch Givens Park in Austin, TX. Note method for protecting toe of slope from erosion. (Photo courtesy of City of Austin, TX)

Figures TS14A-7, TS14A-8, and TS14A-9 show examples of methods used to protect the toe of slopes in a project in the city of Austin, Texas. Figure TS14A-10 shows the use of stream barbs to prevent erosion of the toe of a slope. Protecting the toe of a repaired slope from subsequent erosion is essential to the success of most streambank stabilization projects.

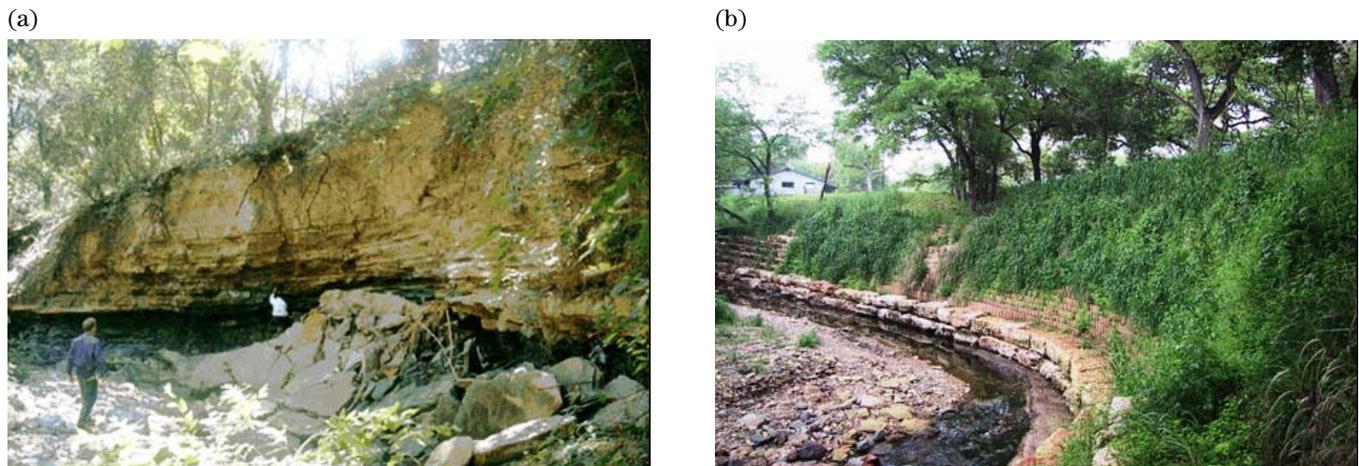
**Figure TS14A-8** Before and after pictures of project, West Bouldin Creek at South 6th Street in Austin, TX. Slope undercut and oversteepened by erosion of toe, which led to sloughing and bank failures. Note method for protecting toe of slope from erosion. (Photo courtesy of City of Austin, TX)

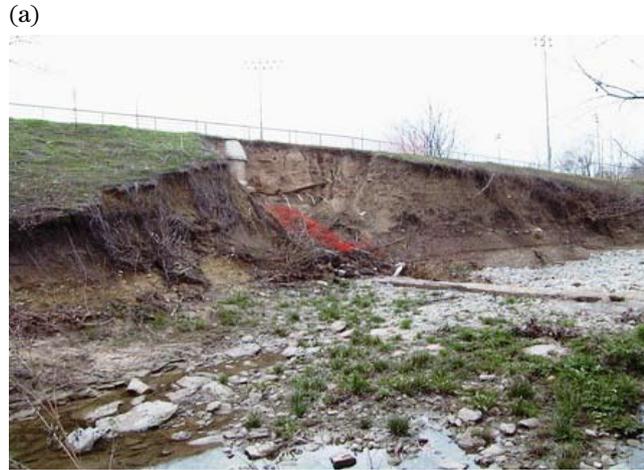
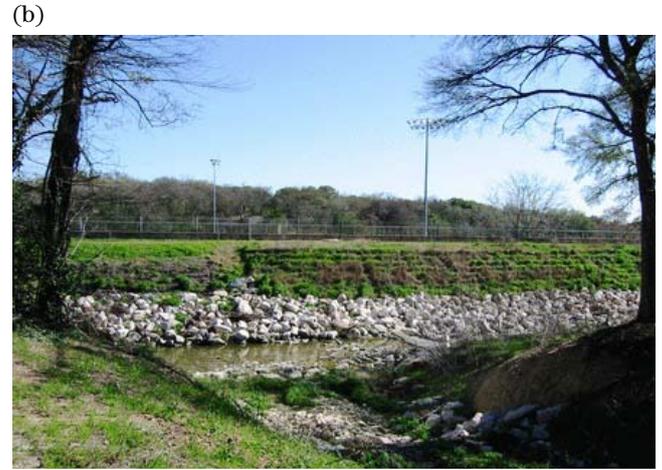
**Figure TS14A-9** Before and after pictures of project, Shoal Creek in Austin, TX. The toe of the slope was protected with riprap and the bank shaped above the protected toe. *(Photo courtesy of City of Austin, TX)*

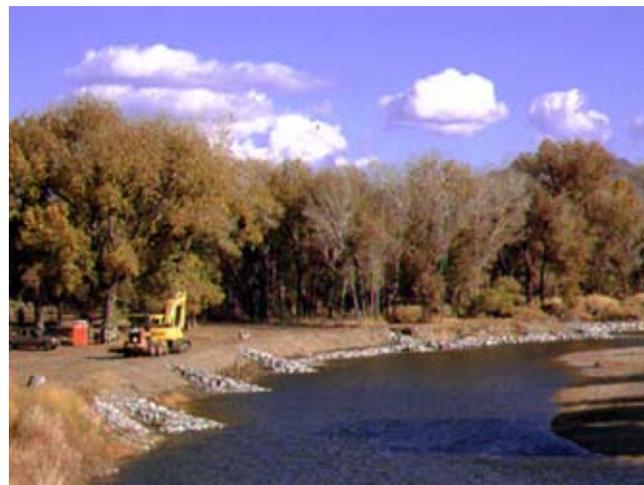
**Figure TS14A-10** Barb structures installed to protect toe of slope from erosion

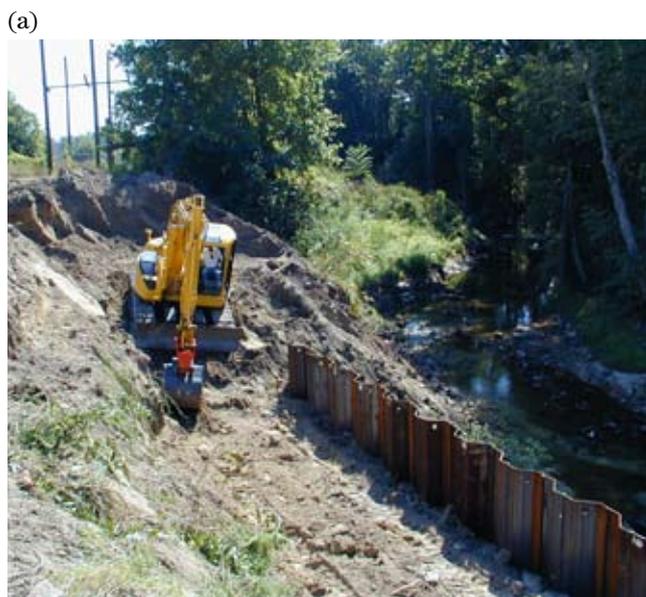
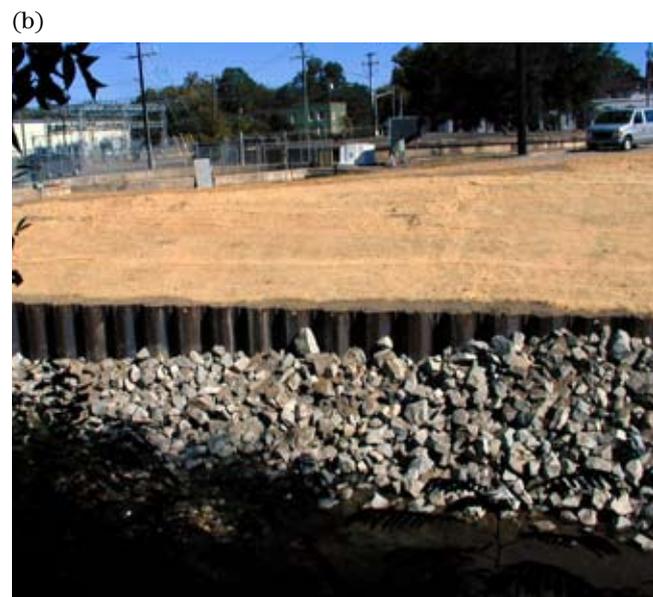
**Figure TS14A-11** Sheet pile wall at toe of slope in Tarboro, NC. Vegetation will be established above wall. Note erosion control fabric.

Figure TS14A-11 shows a project where the toe of the slope was protected using both riprap and a sheet pile wall. In many circumstances, rigid boundary constraints, improvements, or other obstacles at the top of the slope do not allow the slope to be flattened. Consequently, constructing a vertical feature at the toe of the slope may be needed.

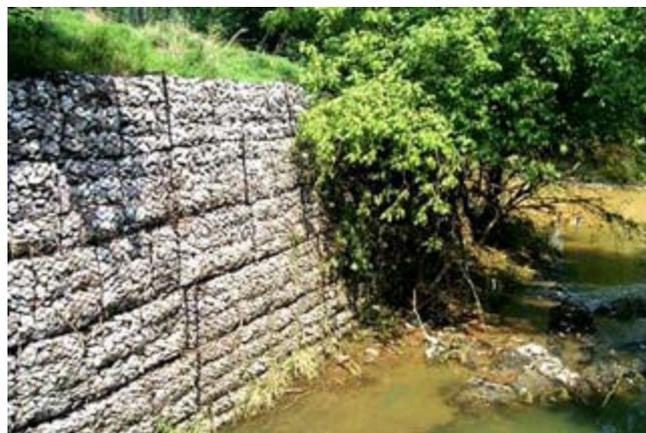
**Figure TS14A-12** Gabion wall constructed at toe of slope enabled reconstruction of failed slope where right-of-way limitations prevented flattening of the upper slope and use of other conventional toe protection measures at the toe

Another way of reconstructing a slope where limited right of way occurs is the use of gabion baskets to protect the toe of the slope (fig. TS14A-12).

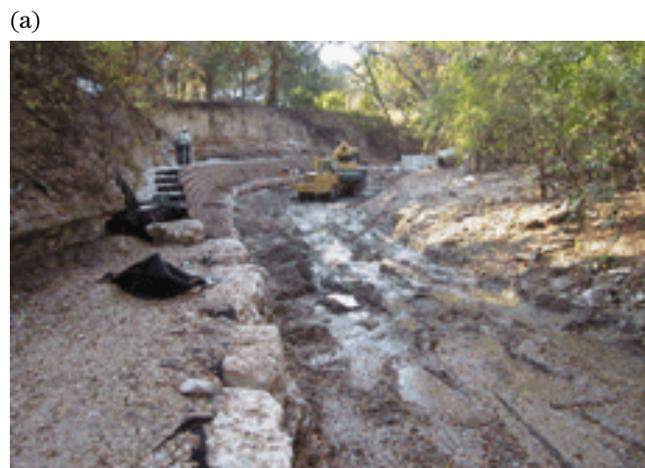
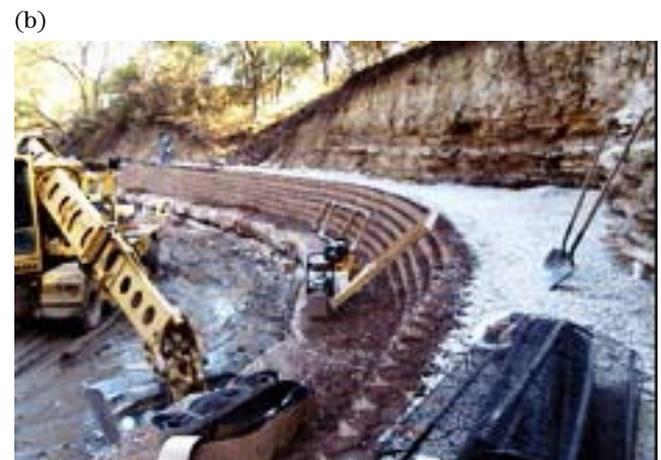
**Figure TS14A–13** Reinforced fill at toe of slope in Austin, TX. Note large stones used to protect reinforced fill from erosive forces in stream.

angle than would otherwise be possible. Examples of geosynthetic reinforcement include the use of geogrids and geocell products. These products are described in NEH654 TS14D. Figure TS14A–13 illustrates a project where the toe of the slope was protected by armoring, and the slope was reconstructed with reinforced soil lifts.

Figure TS14A–13 shows the reconstruction of the slope at the West Bouldin Creek at South 6th Street project. Figure TS14A–13(a) shows the site in the initial stages of construction. The toe of the slope has been excavated in preparation for installing limestone boulder armor

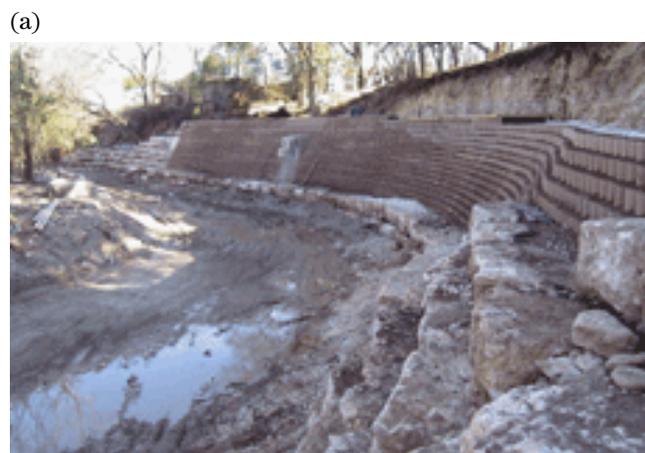
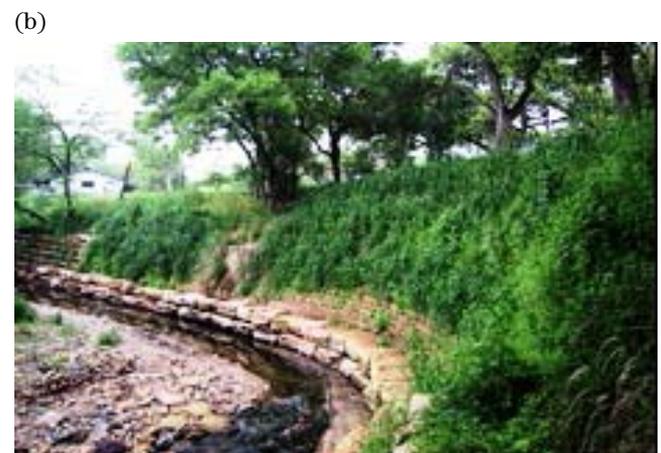
**Figure TS14A–14** West Bouldin Creek at South 6th Street, Austin, TX, project during last stages of construction

Figure TS14A–14(a) shows the West Bouldin Creek at South 6th Street Austin project during last stages of construction, and figure TS14A–14(b) shows the project after completion of the backfill and establishment of vegetation. The use of soil in the filled geocells

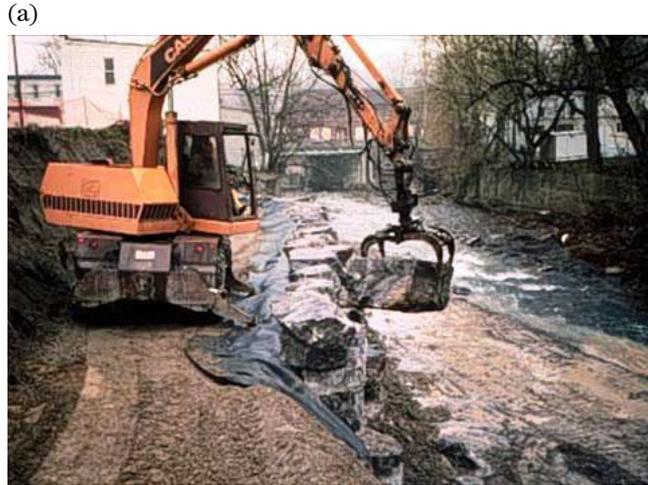
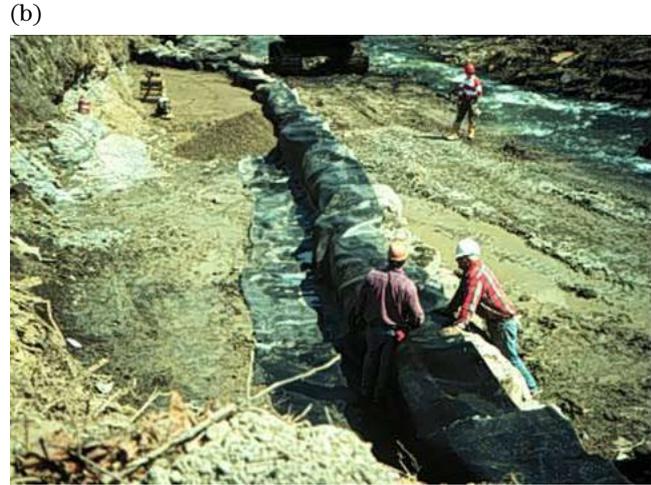
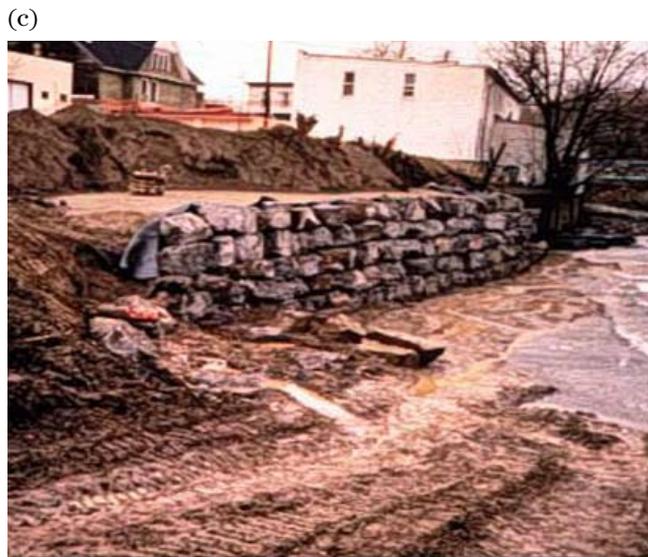
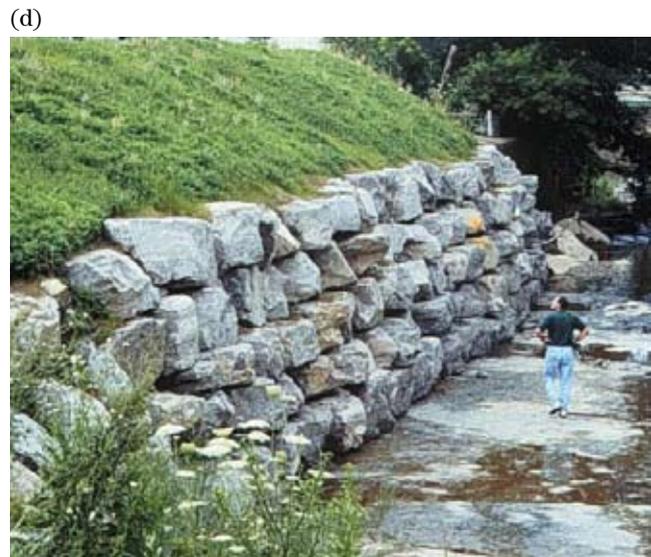
**Figure TS14A-16** Construction of a geotextile reinforced slope with large derrick stone armoring at toe of slope

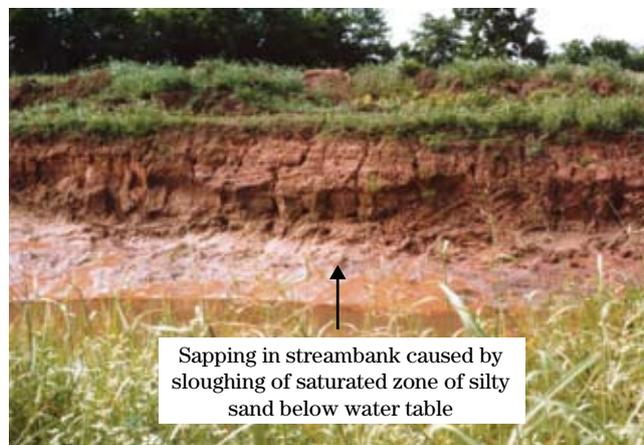
**Figure TS14A–17** Sloughing of saturated low plasticity zone in lower streambanks caused by seepage forces

be able to form a roof. In a related mode of failure, the saturated bank in this zone of low plasticity soils slumps or sloughs under the seepage forces. Sloughing of the lower banks can undermine overlying zones that are stable on a steeper slope. Figure TS14A–17 shows sloughing in the lower saturated banks of an excavated stream.

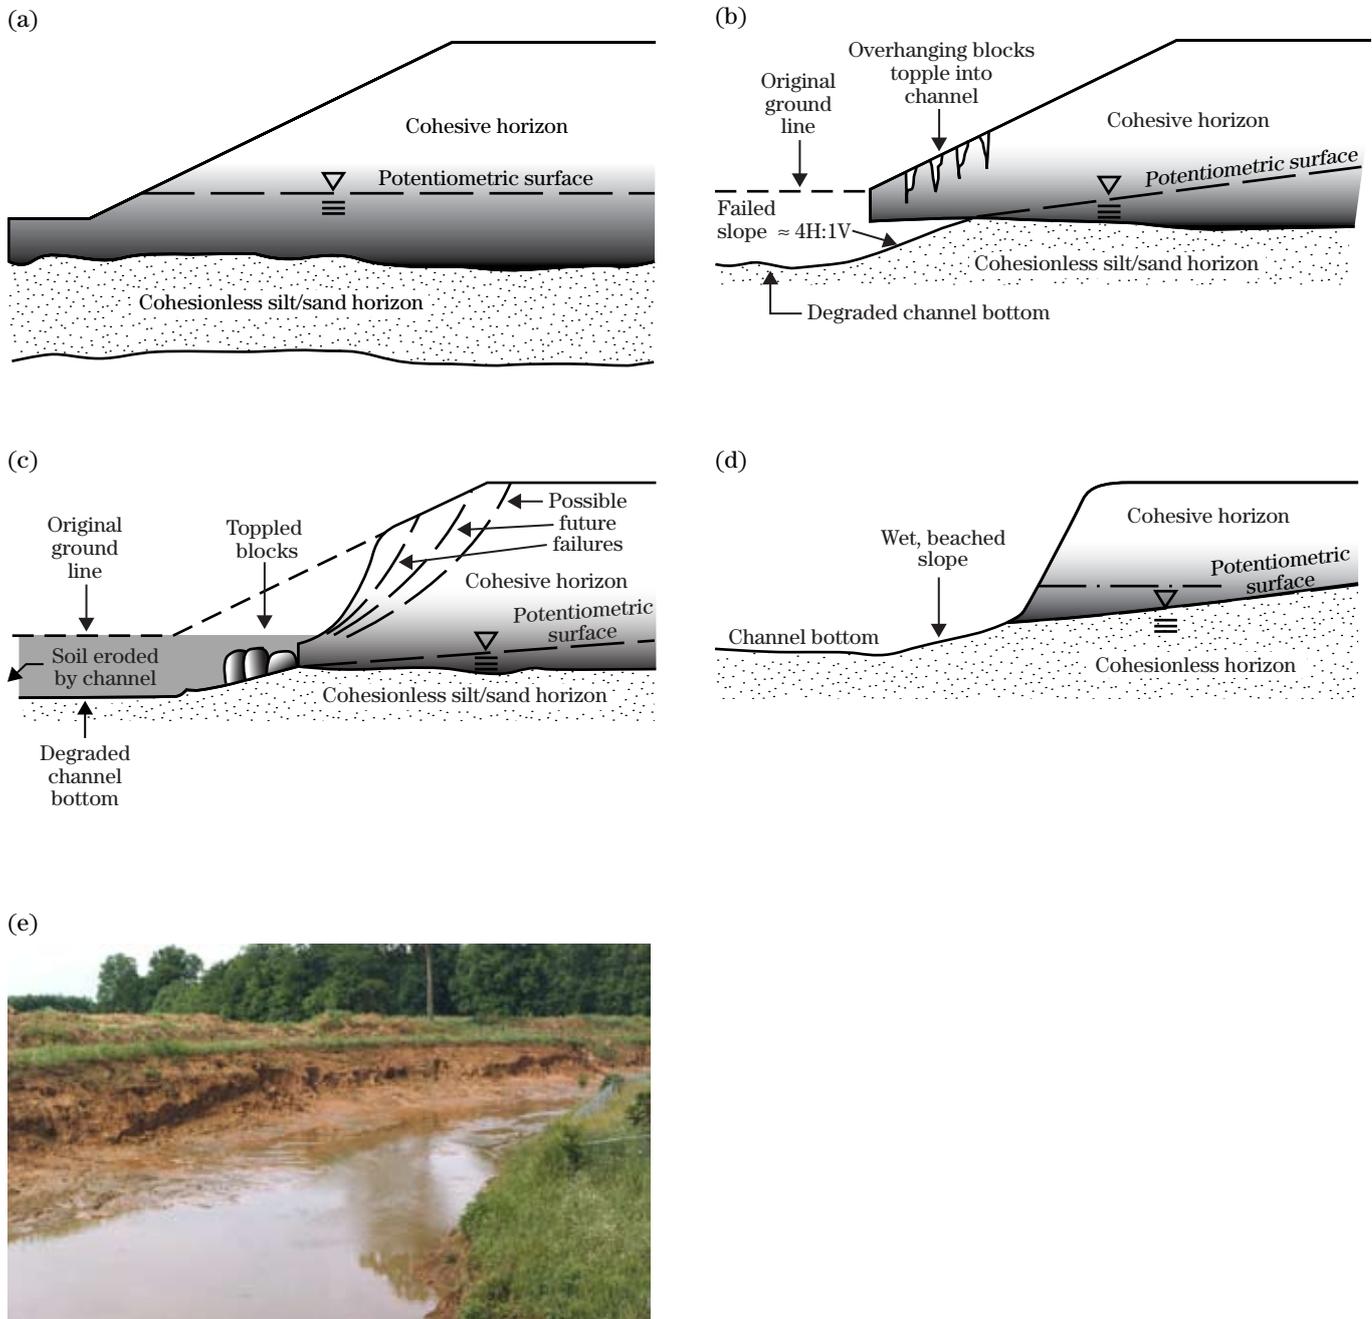
Figure TS14A-18 Progression of sloughing type of failure mechanism in a streambank

These overlying soils then fail by toppling into the stream, as shown in figure TS14A–18(c). If erosion of the lower slopes is occurring or if the streambed is degrading, the process repeats. This results in substantial

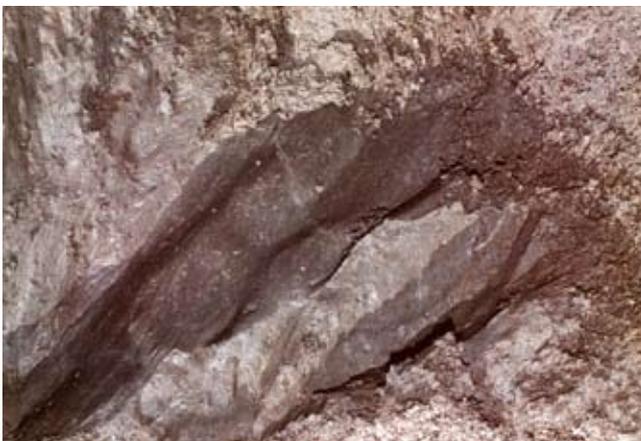
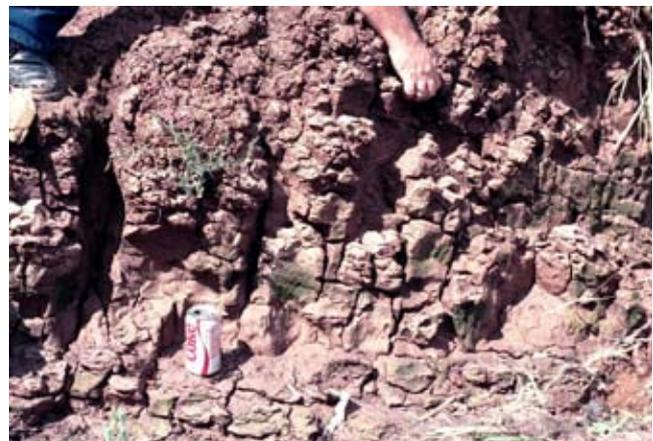
**Figure TS14A–19** Slickensides in exposure of clay soil

Figure TS14A–19 shows photographs of highly plastic clays with slickensides and blocky structure. Shallow surface slides commonly occur in these soils where streams have been modified or the stream system is not in equilibrium and bed degradation is occurring.

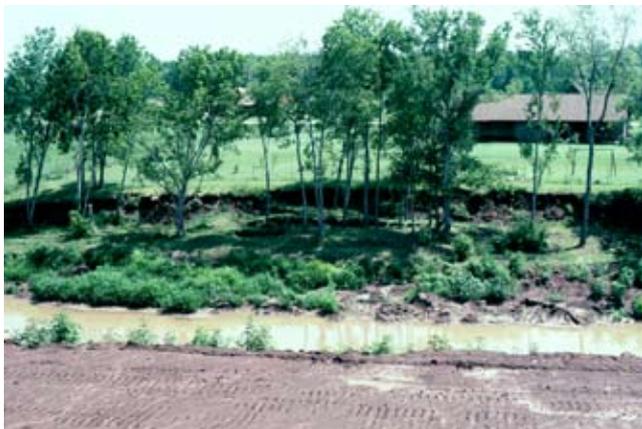
**Figure TS14A-20** Stream slope that failed when the stream was deepened by about 4 feet to increase the flow capacity

Figure TS14A-20 shows a slope failure on a stream-bank that occurred when the stream was deepened about 4 feet to increase the flow capacity and blocky structured clays occurred in the streambanks. Root reinforcement of large trees was inadequate to resist the large forces active in this type of failure. Note that large trees were displaced by the failure.

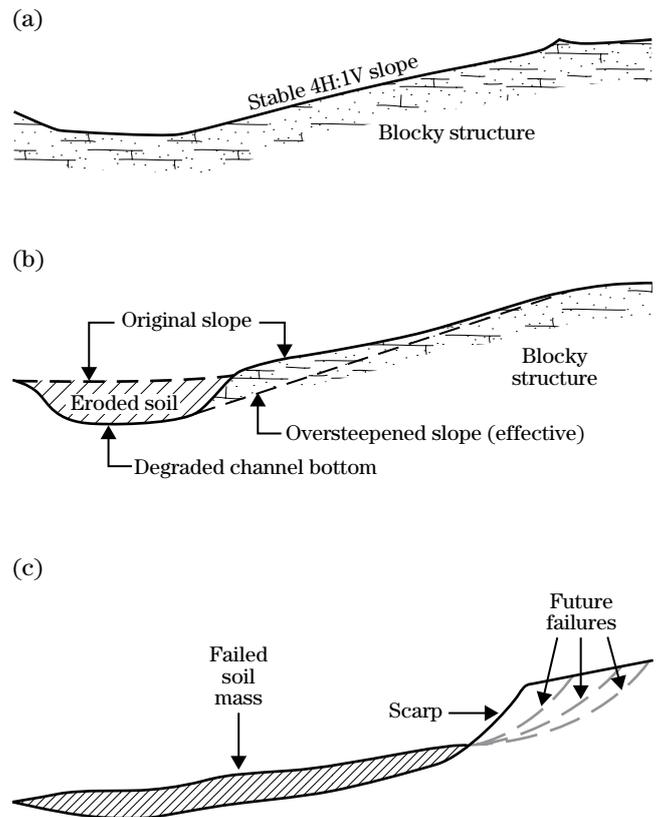
**Figure TS14A-21** Progression of events that can result in bank instability

The series of sketches in figure TS14A-21 show the progression of events that can result in bank instability. Figure TS14A-21(a) shows an initially stable condition prior to stream degrading into a horizon of soils that are susceptible to slope failures because of the blocky soil structure. Figure TS14A-21(b) shows streambed loss or degradation causes an effective steepening of the streamside slopes. The blocky structured clays are subject to slope failures when the stable condition is disturbed.

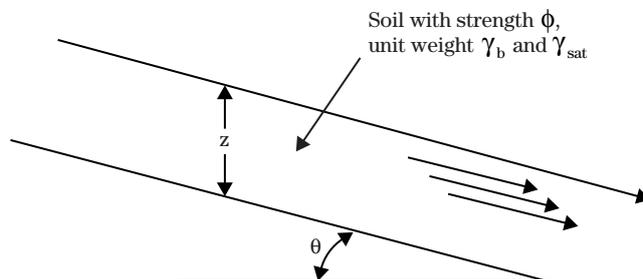
**Figure TS14A-22** Infinite slope equation for slope with small cohesion value

$$FS = \frac{\bar{c} \times \gamma_b \times z \times \cos^2 \theta \times \tan \bar{\phi}}{\gamma_{sat} \times H \times \sin \theta \cos \theta} \quad (\text{eq. TS14A-1})$$

In silty, clayey, coarse-grained soils, a significant cohesion property may be present in effective stress parameters. For this assumption, computerized slope stability analyses can be used to calculate factors of safety by various methods such as the method of slices. These types of computer analyses are not appropriate for zero-cohesion soils because the critical failure surfaces are very shallow on the slope face with factors of safety approaching those obtained using the infinite slope equations.

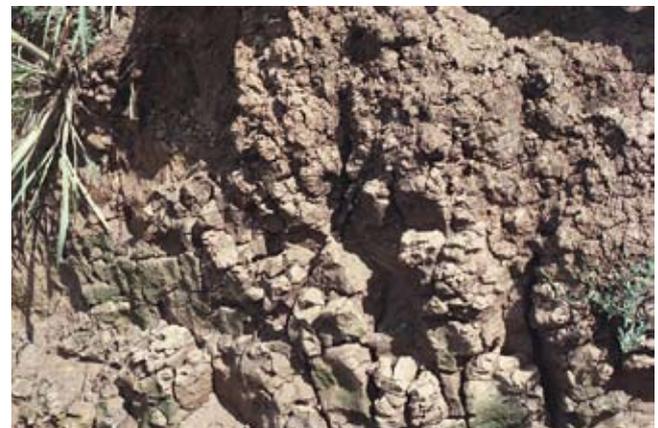
**Figure TS14A-23** Blocky structured clay in streambank exposure

The soils have an observable strongly blocky structure in an exposed face. The blocks of clay may be from one quarter to three-quarter inch in dimension. Figure TS14A-23 shows an exposure in a blocky clay soil. Other photographs show slickensides that are present in many such deposits. Slickensides develop from repeated wetting and drying cycles in clays.

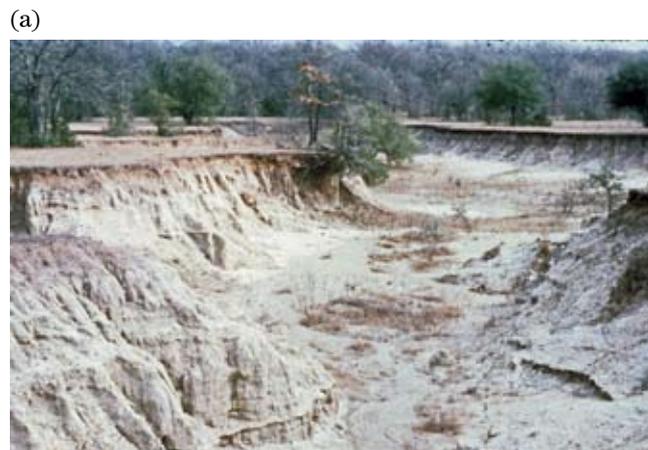
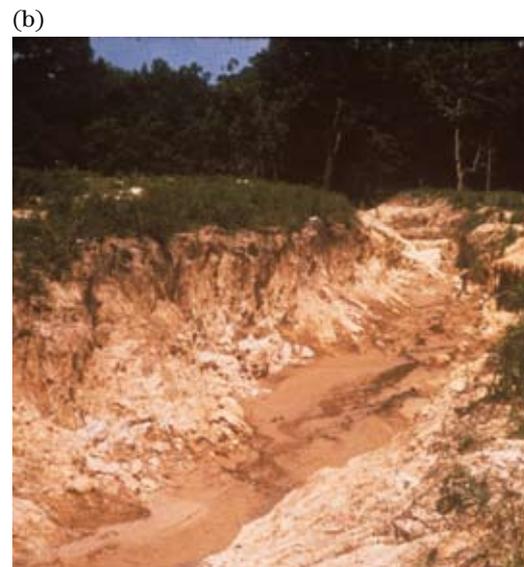
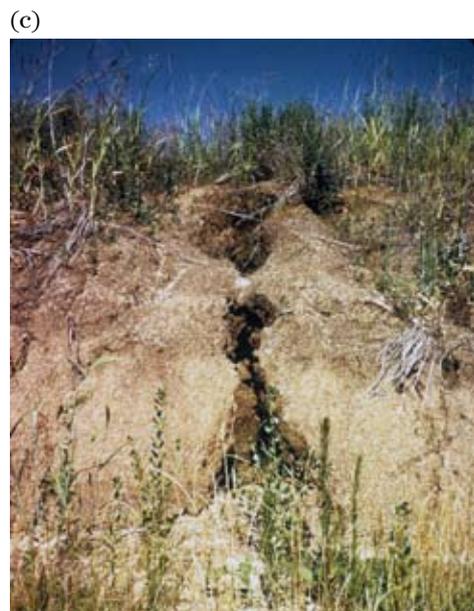
**Figure TS14A-24** Photographs of exposure of dispersive clays in streamside slopes in TX and OK

Dispersive clay slopes often are severely rilled. These rills often develop in a short time. Jugholes are an ideal diagnostic tool for dispersive clays. These features develop when a drying crack in the exposed soil provides an entrance for precipitation that can then erode the sides of the wall. This internal erosion of the crack results in subterranean cavities often termed jugholes. Figure TS14A-24 illustrates the special appearance of dispersive clays.

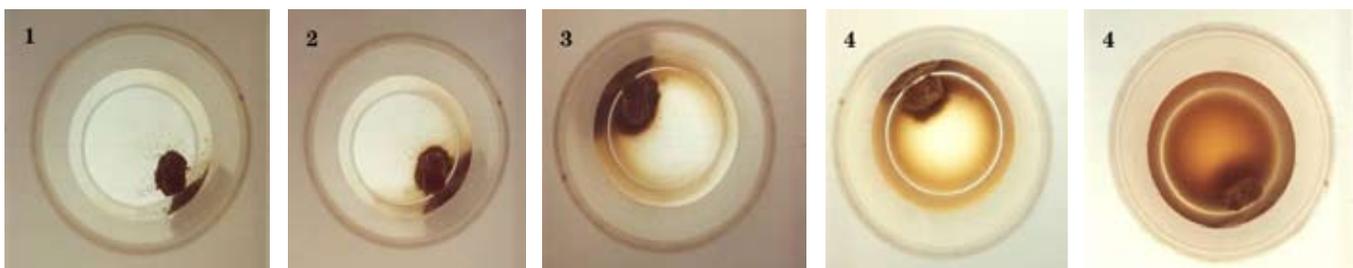
**Figure TS14A-25** Typical reactions in crumb test, a test for dispersive soils

A common field test for dispersive clays is the crumb test, a test for dispersive soils (fig TS14A-25). A small clump of the soil (about a half-inch cube) is placed in a cocktail glass that has about an inch of distilled water, and observed for at least an hour. A rapid formation of a cloud around the soil indicates that it is dispersive. The observed reaction is typically given a rating from the criteria listed.

An excellent field test for dispersion is the crumb test. ASTM Standard Test Method D6572 covers methods for performing the test. The test requires a minimum of equipment and is excellent for screening purposes to determine if dispersive clays are likely present.

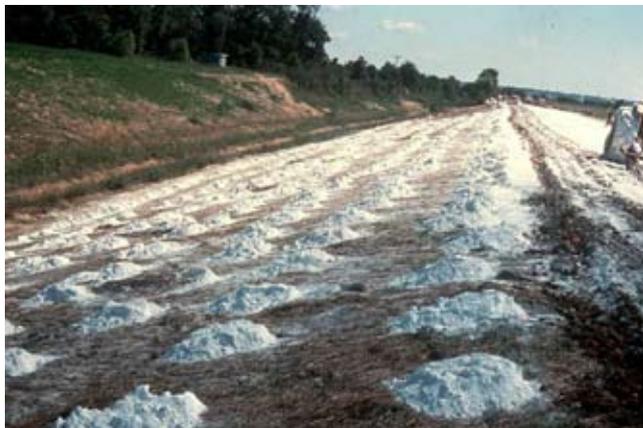
**Figure TS14A-26** A streambank where highly dispersive clays were treated by applying and mixing in hydrated lime to the slope soils

Another method for treating dispersive clays is to chemically alter the soils. Dispersive clays are predominated by sodium, and replacing the sodium ions with calcium, magnesium, or aluminum ions improves the interparticle attraction of the clays. Chemicals that have been successfully used include hydrated lime (fig. TS14A-26), quick lime, fly ash, alum, and gypsum. Refer to Soil Mechanics Note 13 for more detailed information.

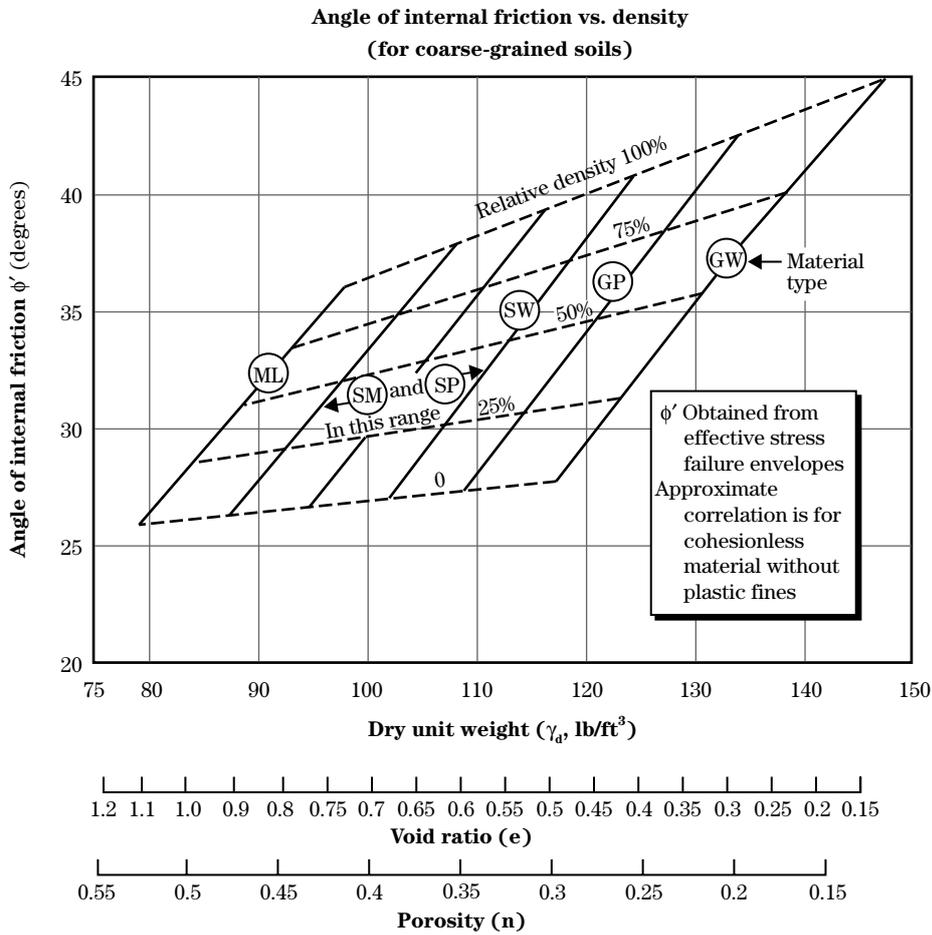
Figure TS14A-27 An example of a chart used to estimate effective friction angles for different types of soils
