# Case Study 17

Stream Barbs on the Calapooia River, Oregon

Part 654 National Engineering Handbook

By Scott Wright, P.E., area engineer, U.S. Department of Agriculture, Natural Resources Conservation Service, Tangent, Oregon

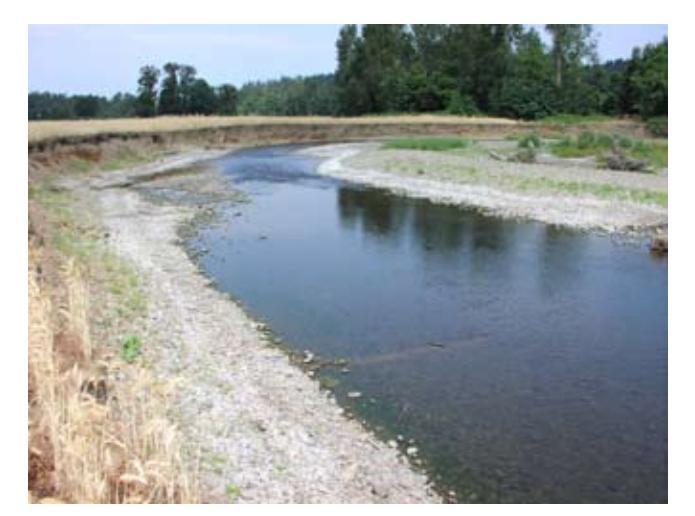
#### Figure CS17-1

Calapooia River project (Photos courtesy of Scott Wright)

(a) Preproject conditions looking downstream at outside bank during summer low flows

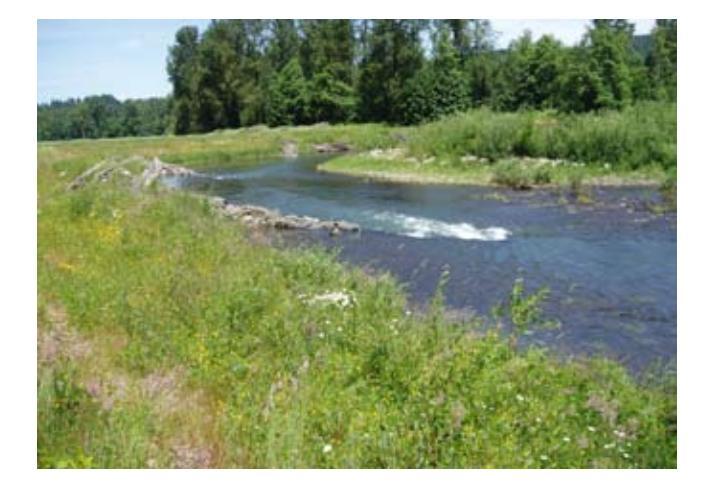
(b) Postproject conditions looking downstream at outside bank during summer low flows

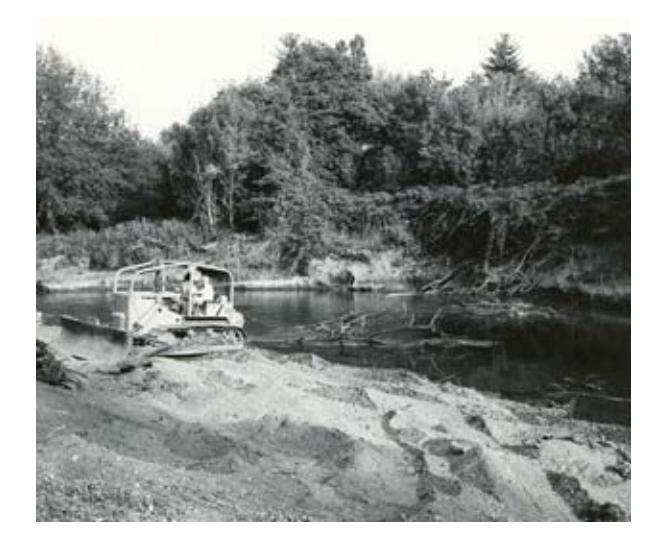
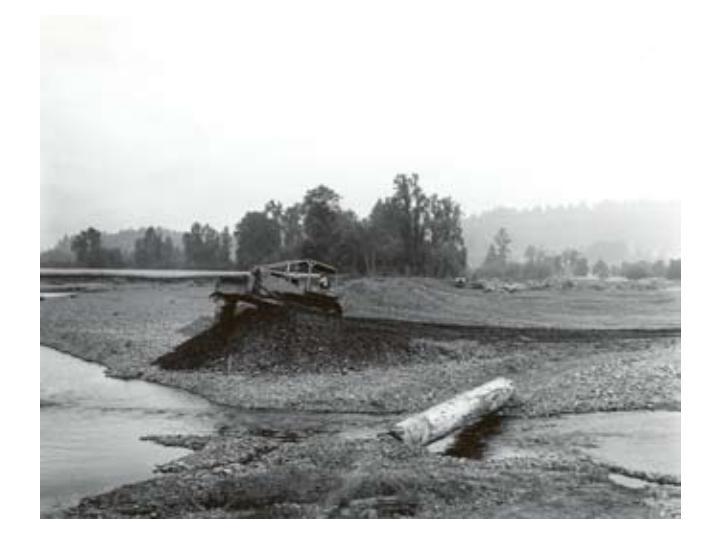
#### Figure CS17–2 Channel alterations in the Calapooia River in 1950s

Based on the Calapooia Watershed Assessment by the local watershed council, significant channel alterations had been performed from 1900 to 1980. Figure CS17–2 illustrates typical work in the watershed.

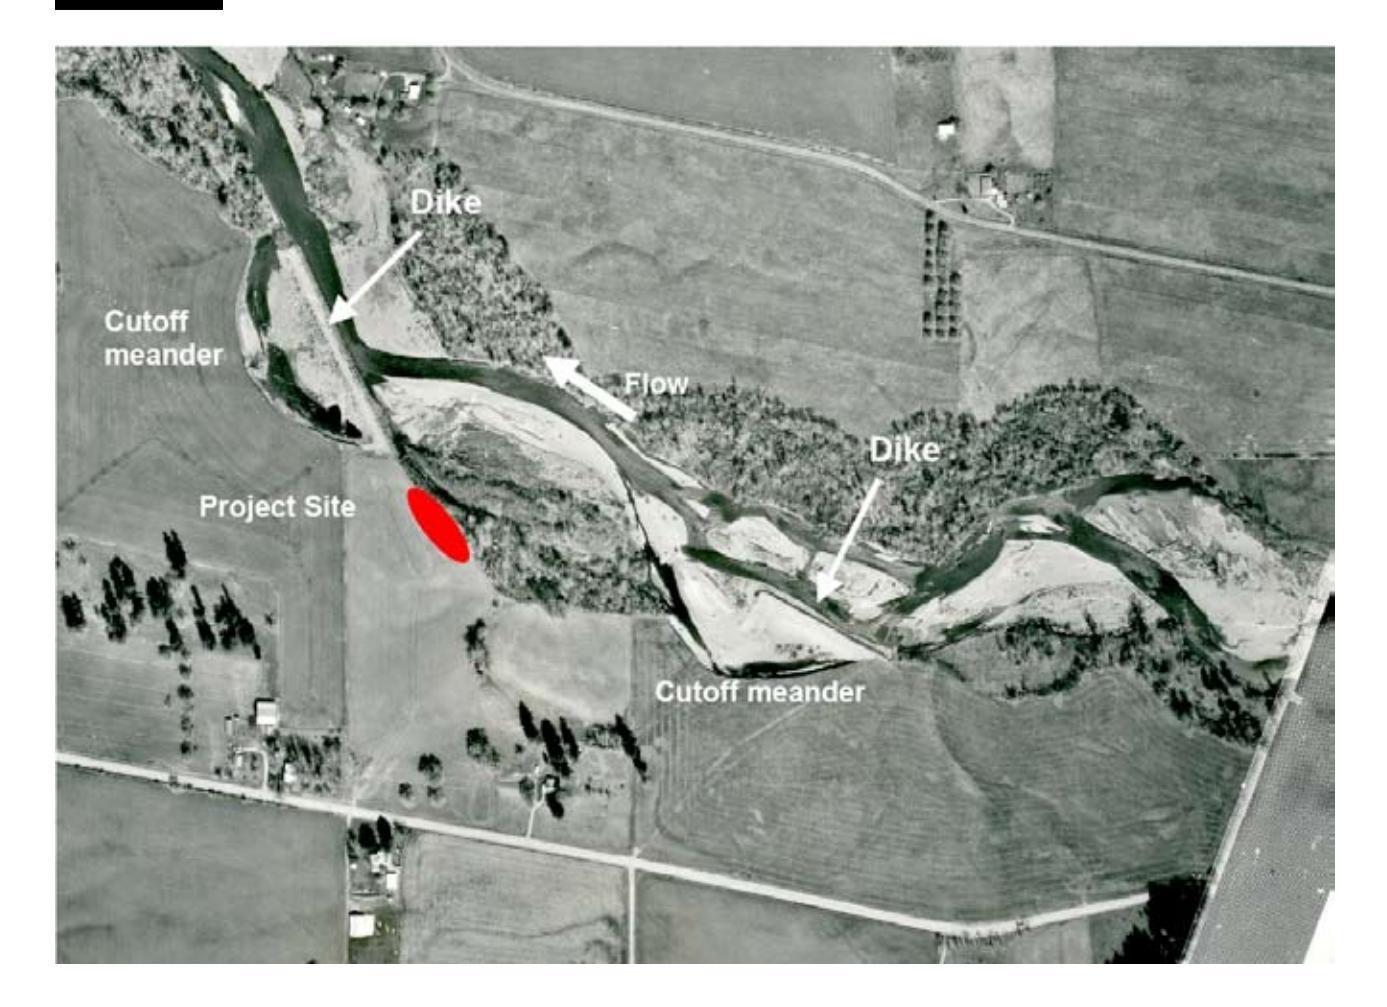
Figure CS17–3 Aerial view of project area in 1966 showing dikes used to cut off meanders

An aerial photo from 1966 (fig. CS17–3 (modified from U.S. Army Corps of Engineers (USACE) photo)) shows a dike just downstream of the project site constructed from excavated instream materials placed to cut off a meander bend. In addition to the channel realignment at the project site, another cutoff dike was constructed

two meander bends upstream from the project site to cut off another meander.

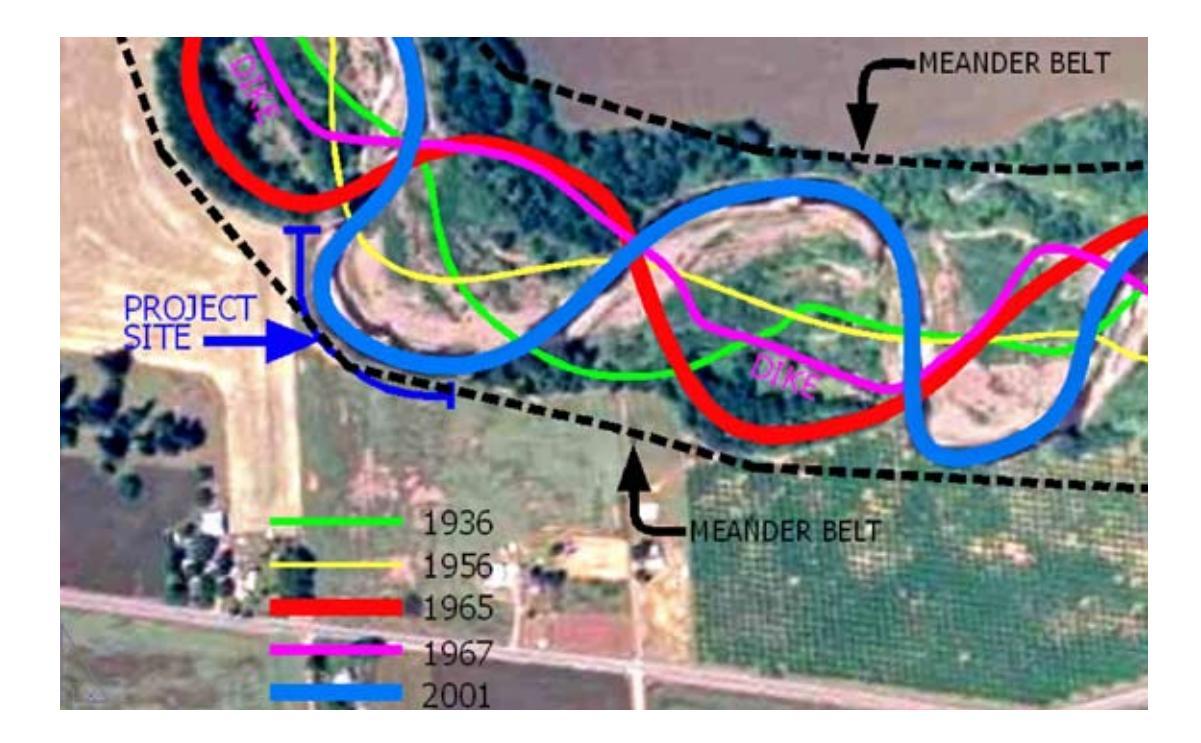
Figure CS17-4 Historic channel traces with corresponding year designated by color

To document historic channel alterations and natural changes, a composite picture of channel alignments was assembled. Figure CS17–4 shows the historic channel alignments from 1936, 1956, 1965, 1967, and 2001, superimposed on the 2001 aerial photo. The river's response to the 1966 meander cutoff dikes is readily visible as the meander phase shifted 180 degrees based on a sine curve relationship. The current river location mirrors the predike conditions in 1965. Analysis of traces of the historic channel highlights the heavily altered state of the river and the dynamic response to stream modifications. Based on nearly 70 years of channel traces, the meander belt width measures approximately 1,000 feet.

It is clear from the analysis of the historic channel that the project area is located near the outer edge of the historic meander migration zone. This allows for more streambank stabilization options because the stabilization will not have an impact on overall planform, nor would it affect flood plain connectivity since the project would not change top-of-bank elevations.

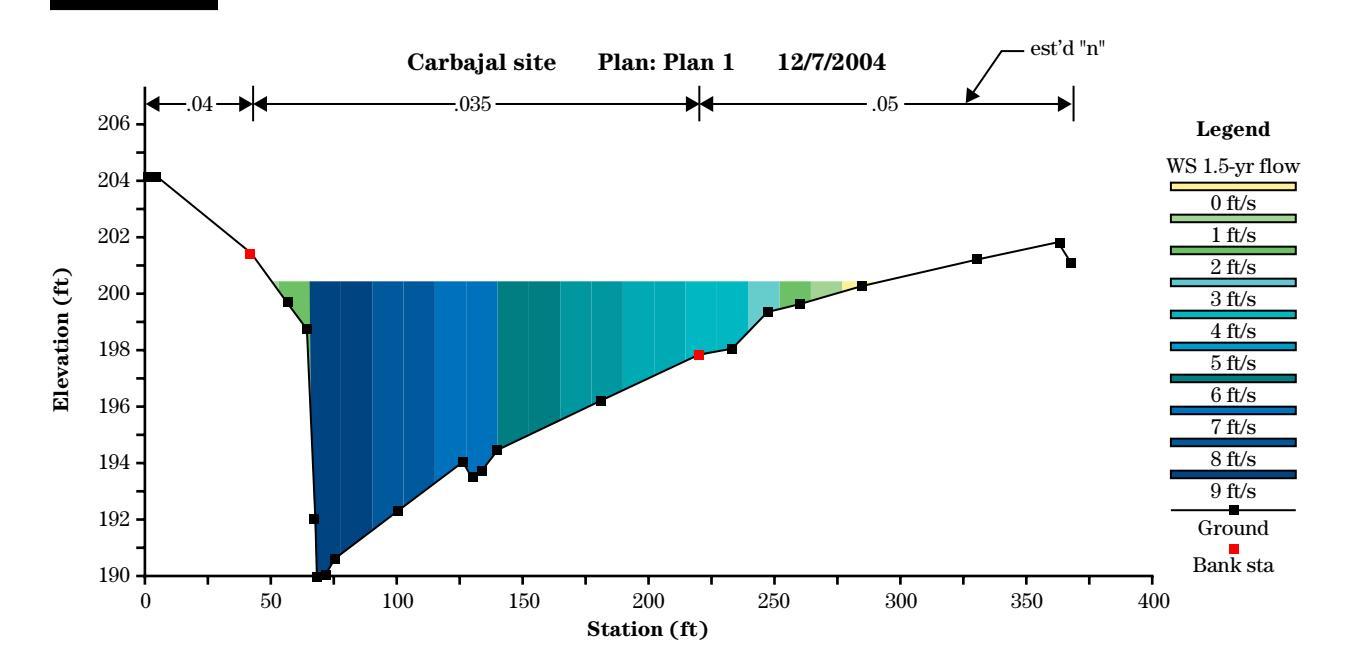
Figure CS17-6 HEC–RAS velocity distribution output for a typical cross section

A steady-state HEC–RAS model was developed based on topographic site survey and hydrologic conditions. The model was used to generate hydraulic characteristics of the site, as well as velocity distributions. In addition, the bankfull flow was determined based on physical features from the site survey combined with the HEC–RAS model and peak flow records. A typical velocity distribution cross section from HEC–RAS is shown in figure CS17–6 at bankfull stage.

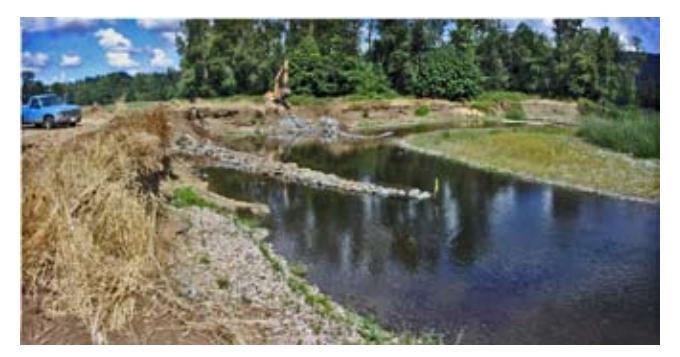
#### Figure CS17-7

The rock barbs were the first component to be constructed. The barbs were staked out using steel "T" posts driven into the riverbed along the design alignment. This practice allowed the contractor to work on the streambank and have a constant view of the proper barb alignment. Figure CS17–7 shows the two downstream barbs immediately after construction and prior to any bank shaping.

Looking downstream at initial installation of two barbs before bank shaping, during low summer flows (*Photo courtesy of Scott Wright*)

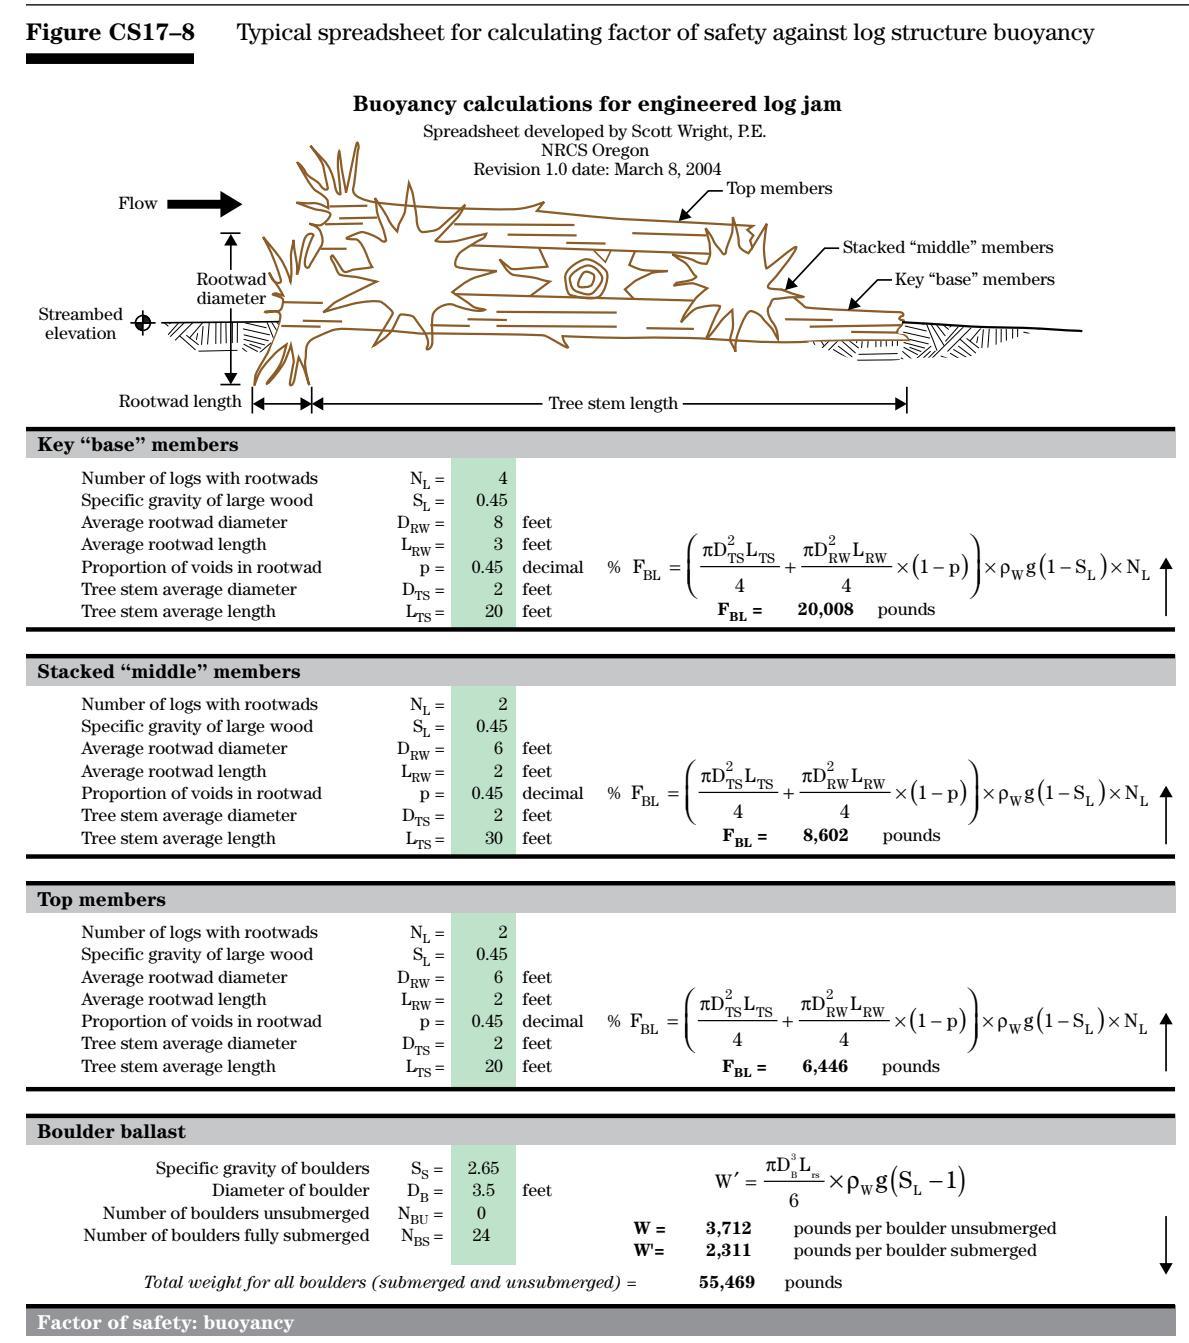
Engineered log structures were installed at each end of the project to provide immediate fish habitat, provide a mechanism for catching large woody material, and act as anchor points to reduce the erosion potential and reduce the likelihood of flanking the barbs. Logs with rootwads were placed together to form a structure that was ballasted with large rock. The ballast rock was designed using D'Aoust and Millar's (2000) performance-based research which is similar to NEH654 TS14J. These authors state "lateral drag forces do not need to be considered explicitly and the factor of safety against buoyancy can be used as a simple design criterion" for multiple log structures that are tied together. Therefore, a buoyancy calculation was used as the design basis for the log structures (fig. CS17–8).

A simplified approach is used to estimate buoyancy where the logs and ballast boulders in the logjam are fully submerged. In addition, the logjam and boulders act as a composite structure and are assumed fully connected. Water velocity inside the logjam is highly turbulent and near zero, therefore, vertical uplift forces are assumed negligible.

$$\label{eq:FSB} \begin{split} \mathrm{FS}_{\mathrm{B}} &= \frac{\mathrm{W} + \mathrm{W}'}{\sum \mathrm{F}_{\mathrm{BL}}} \\ &= 1.58 \qquad \mathrm{FS}_{\mathrm{B}} = -1.58 \end{split}$$

D'Aoust and Millar (2000) recommend a minimum factor of safety of 1.5 against buoyancy for log structures. Based on experience using log structures in Oregon, this minimum factor of safety against buoyancy is an adequate design parameter. However, it is recommended that the factor of safety be closer to 2.0 and that the large wood be connected together to allow the structure to act as a single unit. These connections also provide better stability in the structure for placing ballast material. The higher factor of safety also allows for greater flexibility during construction when working with imperfect and irregular logs.

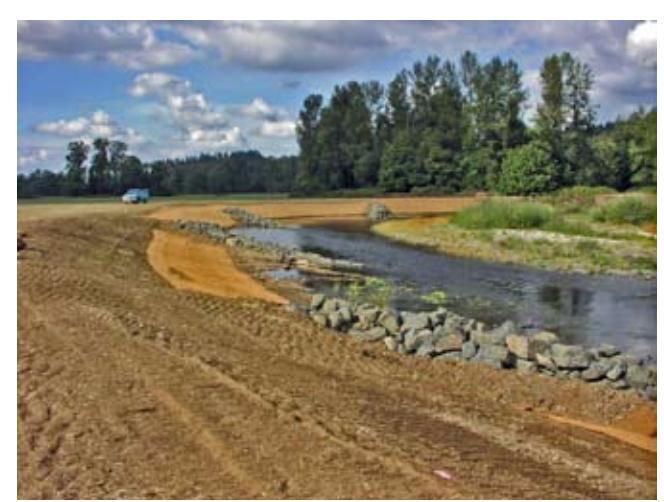
### Figure CS17-9

Looking downstream at completed project showing barbs and erosion control mat during summer flow (*Photo courtesy* of Scott Wright) Figure CS17–10

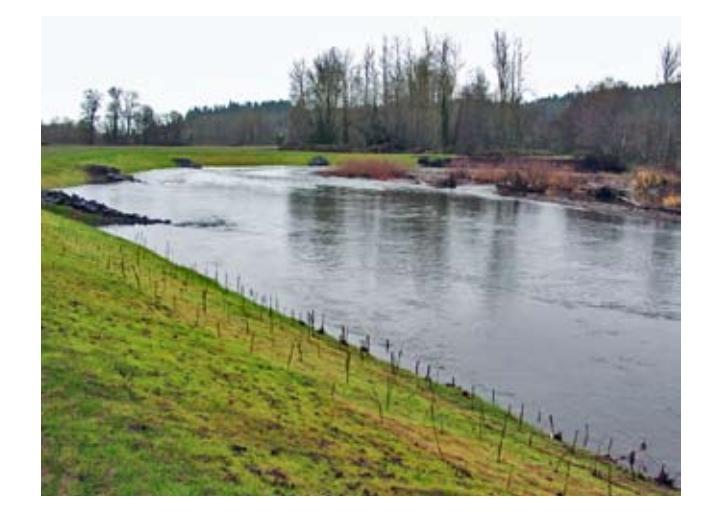
Winter baseflow with planted willows and grass

Just 3 months after project completion, a gaged storm event occurred that measured between a 5- and 10year peak flow. The project withstood the storm event with no noticeable erosion or adverse effects to the surrounding area (fig. CS17–10). Large amounts of wood collected on top of each barb and especially near the downstream third of the meander bend—at the engineered log structure (fig. CS17–11).

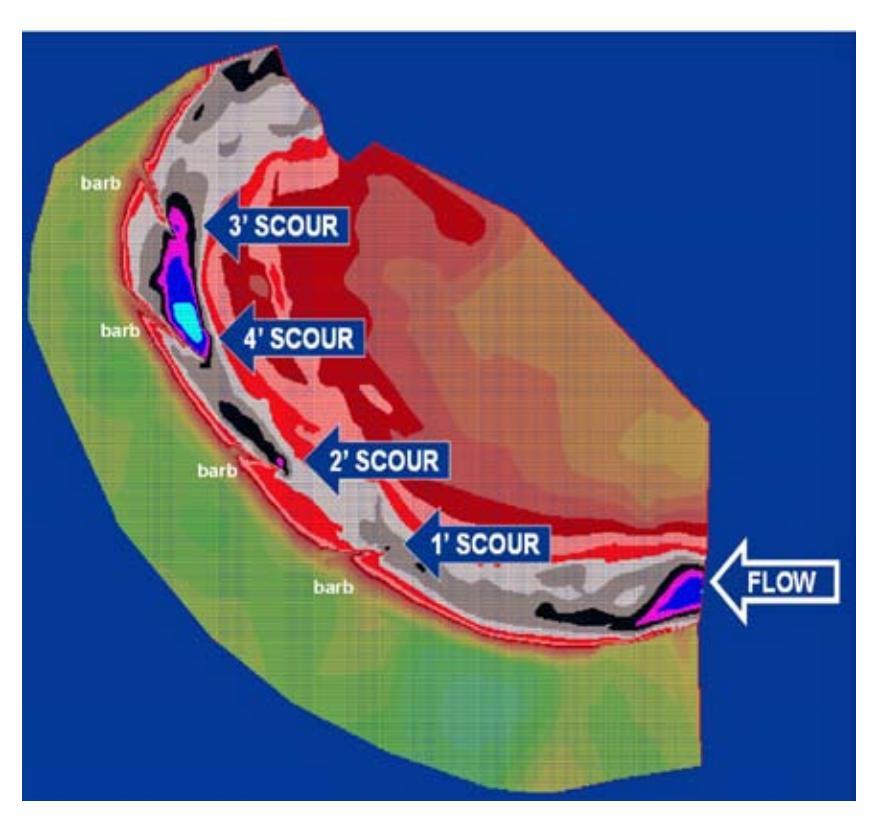
## Figure CS17-12Actual scour around each barb following 5- to 10-year peak flow event. Each color band gradient represents<br/>a 1-foot elevation increment. (Photo courtesy of Scott Wright)

Detailed topographic information was collected preand postconstruction to identify actual geomorphic effects of the stream barbs and overall performance. Figure CS17–12 identifies the actual scour that occurred around each barb and the streambed.

Because of the barbs, no scour or erosion occurred along the outside bank of the meander. As illustrated in figure CS17–12, the hydraulic effect of the barbs caused local scour and constriction scour. The scour pattern begins around the tip of the barb and extends downstream in an elliptical shape. This pattern is similar to other observations made in Oregon around barb groups on C3 and C4 gravel-bed rivers. Energy dissipation within the project reach is caused by scour and a hydraulic jump at each barb. Figure CS17–13 shows the distinct hydraulic jump as water flows over the barb. This jump is progressive with stage because of the crest slope of the barb weir. Based on this project and several other observations of barbs, a 15H:1V slope appears to be an optimal weir slope to enact the hydraulic jump throughout various discharge stages.

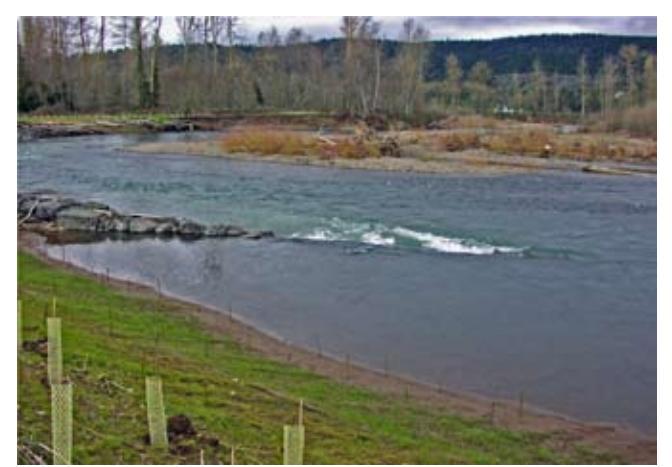
### Figure CS17–13

Example of energy dissipation from a hydraulic jump formed over one of the project barbs during winter baseflow (*Photo courtesy of Scott Wright*)

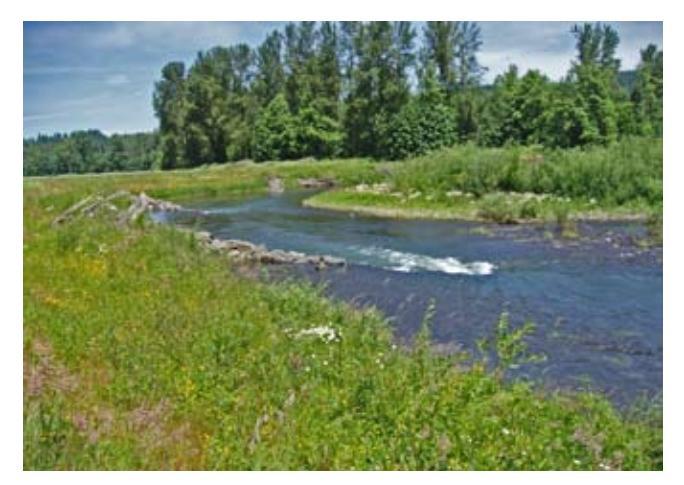
erosion problems downstream. Figure CS17–14 shows the completed project 3 years after construction. A significant number of willows now grow in the reach corridor and further reduce near bank flow velocities. The vegetation provides habitat to promote biodiversity that was not present in the preproject state.

Looking downstream 3 years after project completion with extensive vegetation growth (*Photo courtesy of Scott Wright*)
